DILIGENT

Home Inspection Report

2217 Lindell Avenue
Nashville, TN 37204

Wednesday, December 2, 2020

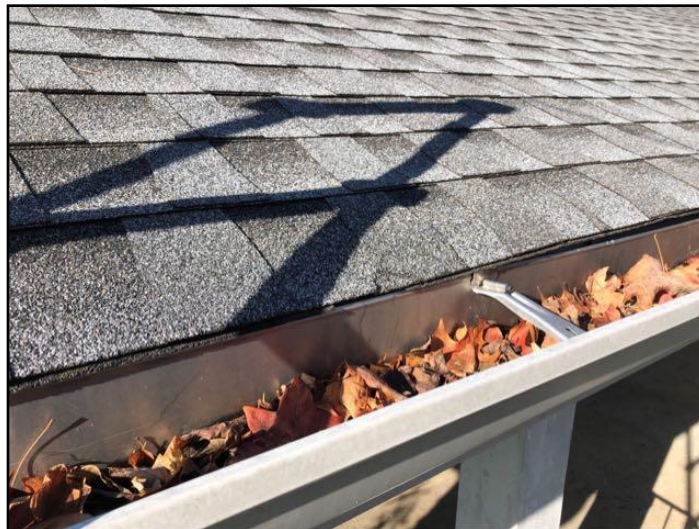
1. Overhangs too big or too small

1. Condition: • [Overhangs too big or too small](#)

In some areas of the roof, the shingle overhang was insufficient. As a result, shingles are terminating short of the gutters. This can cause rainwater to flow behind the gutters and onto the fascia board instead of into the gutters. Repairs to the shingles by a licensed, qualified, roofing contractor is recommended. Typically, asphalt shingles without drip edge flashings are cut to a depth of approximately 1 to 1 1/2 inches.

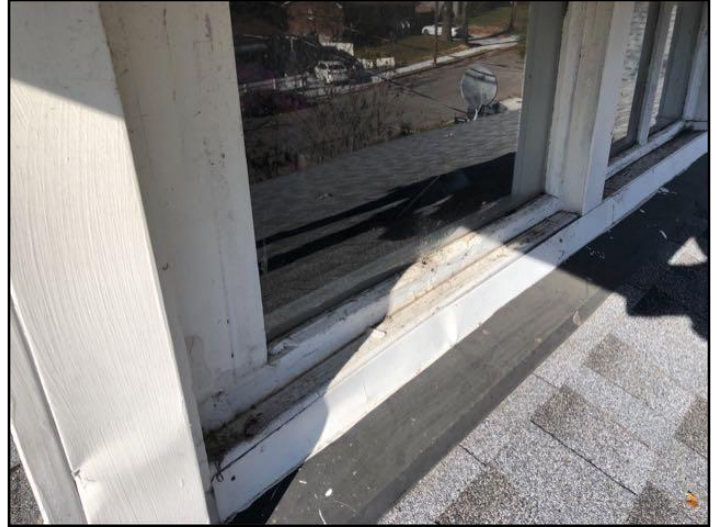
3. Loose, damaged, patched, open seams

2. Condition: • [Loose, damaged, patched, open seams](#)

The apron flashing installed at the base of the dormer was loose, the top edge of the flashing was not sealed, and the fasteners were exposed. Repairs are needed to the flashing to prevent moisture intrusion.

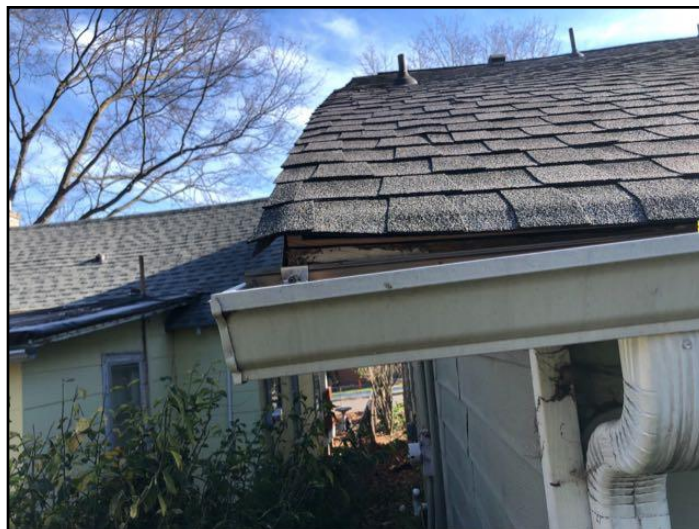
4. Missing

3. Condition: • [Missing](#)

A section of gutter on the back right corner of the home left the fascia board exposed. Bare wood of the fascia was visible from the exterior. It is recommended for flashing to be installed in this area to prevent moisture from damaging the wood components in this area.

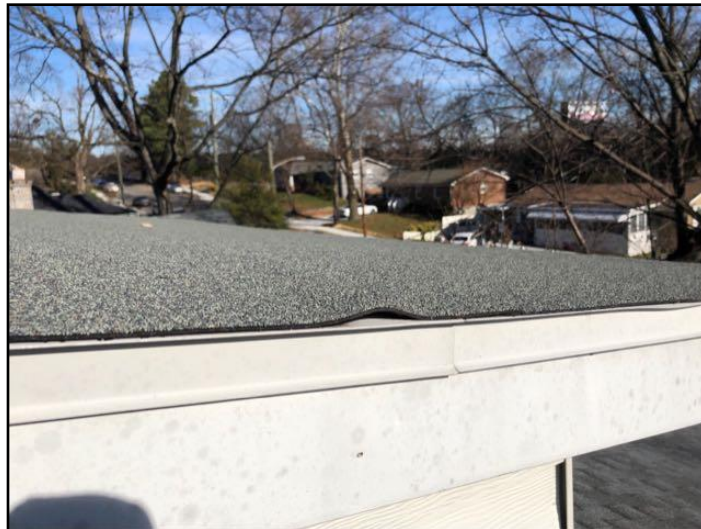
5. *Openings at seams or flashings*

4. Condition: • [Openings at seams or flashings](#)

Minor openings were present at the roll roofing edges on the dormer of the home. The roll roofing had separated from the flashing, leaving a vulnerable area for moisture intrusion. It is recommended for repairs to be made to the roofing and flashing.

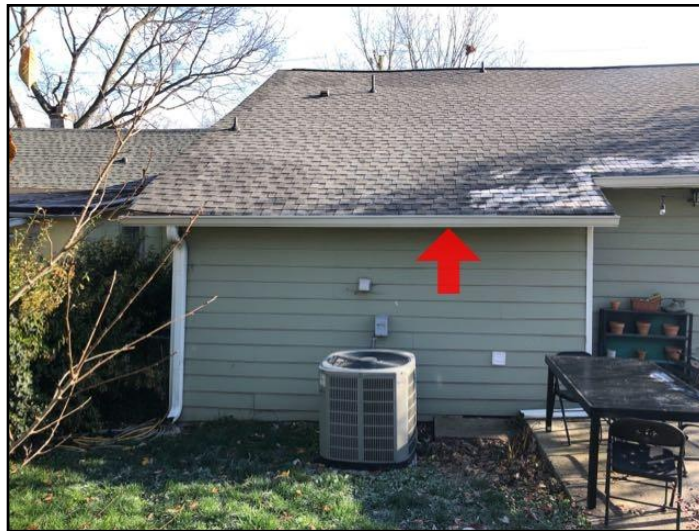
7. Improper slope, ponding

5. Condition: • [Improper slope, ponding](#)

Gutters should be sloped toward downspouts to promote good flow and prevent standing water within the gutter. The gutter on the back of the home was oriented with a high spot in the middle and a downspout on one end. It is recommended for the slope of the gutter to be adjusted to alleviate this issue.

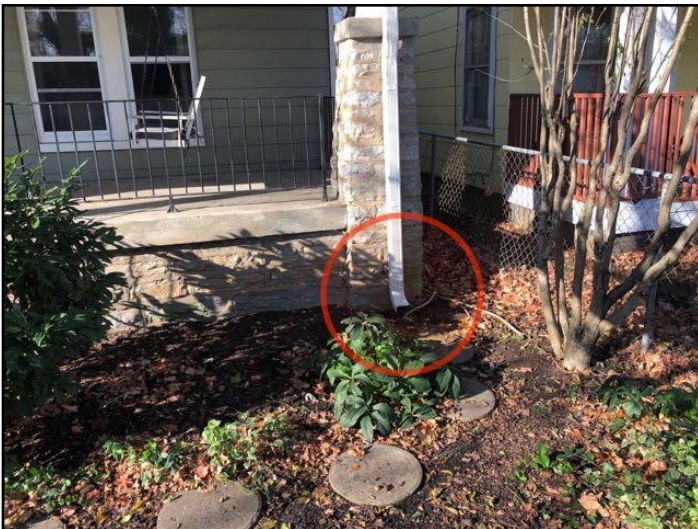
9. Discharge too close to building

7. Condition: • [Discharge too close to building](#)

It is a good practice to extend downspouts to allow them to discharge at least 4 to 6 feet away from the home. Moisture collection near the foundation can result in settlement and/or moisture issues beneath the home. Downspout extensions are available at home/hardware stores.

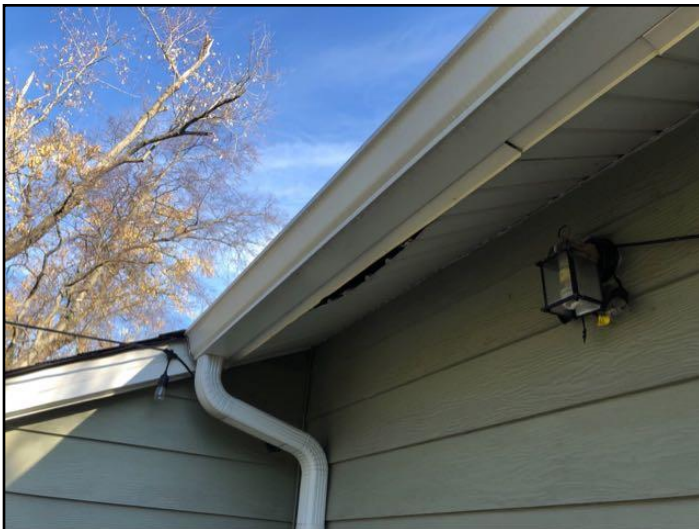
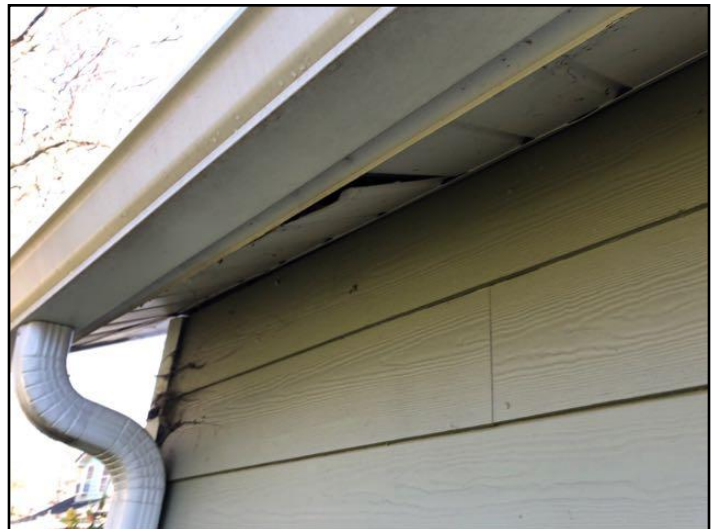
8. Condition: • [Loose or missing pieces](#)

A few sections of the vinyl soffit was loose on the back of the home. The sections should be secured to prevent damage from high winds and pest intrusion.

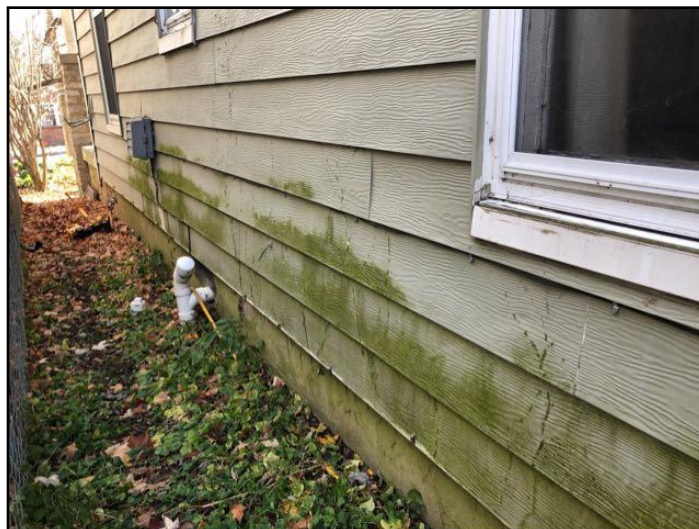
15. *Discolored*

10. Condition: • [Discolored](#)

Organic growth was noted on the metal siding on the right side of the home. This is primarily a cosmetic issue, the siding can be cleaned as regular maintenance to prevent this growth.

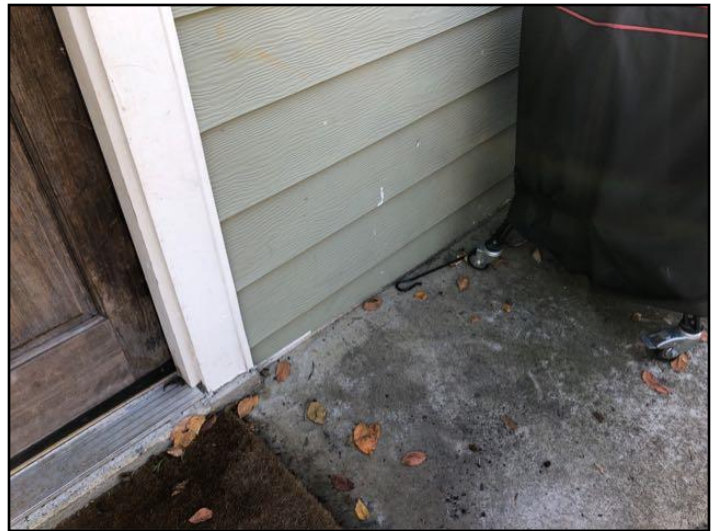
19. Too close to grade

e grade on the left side of the structure. It is recommended to have a minimum of a 1" gap between the siding and any hardscape (concrete, asphalt) surfaces and a minimum of 6" over softscape (soil) to prevent moisture wicking into the structure. Repairs to the siding by a qualified, licensed, professional is recommended.

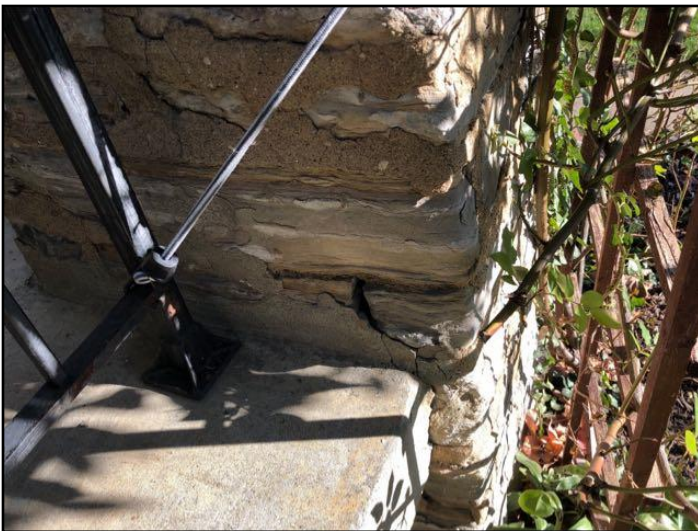
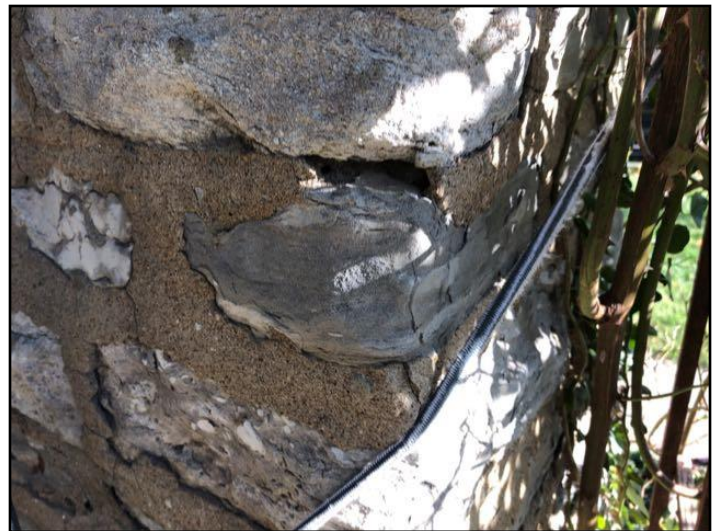
13. Condition: • [Mortar deterioration](#)

Minor mortar deterioration was noted on the front stone columns. It is recommended for the voids to be filled with mortar to prevent further deterioration.

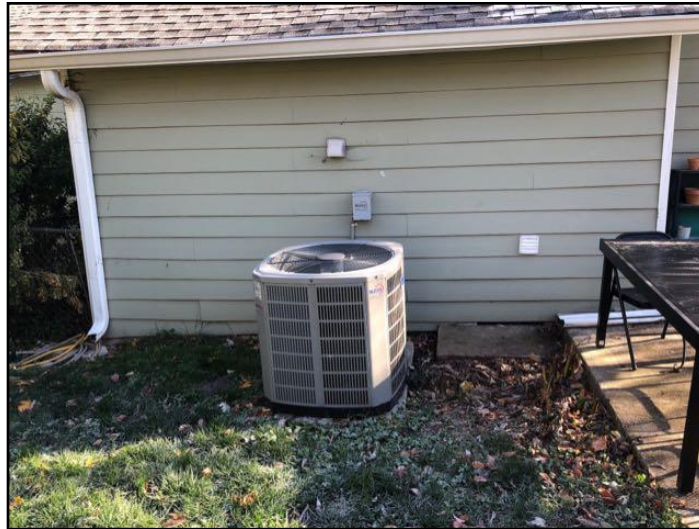
24. *Too close to grade*

14. Condition: • [Too close to grade](#)

Manufacturers commonly recommend that fiber cement siding be installed at least 3-6" above grade and 1" above hardscape (e.g. patios, sidewalks, driveways). The siding/trim at the described location was not installed in accordance with these criteria. Installations such as this can result in mechanical damage to the siding, due to spalling or freeze d

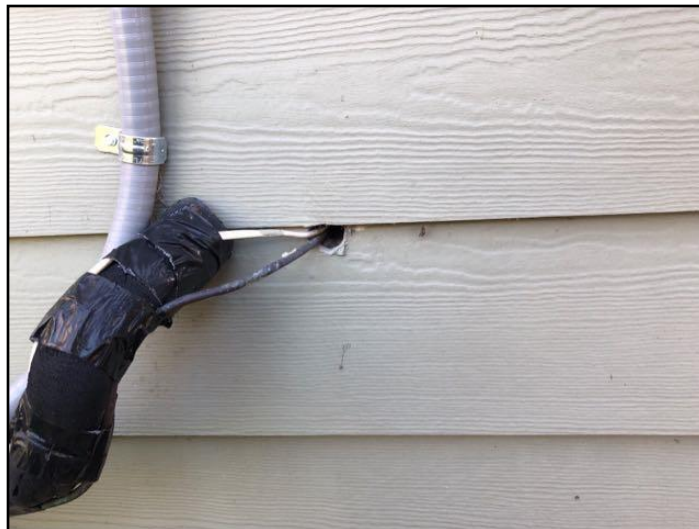
25. *Unsealed Openings in Siding*

15. Condition: • Unsealed Openings in Siding

It is recommended that any openings or gaps which penetrate the fiber cement siding be sealed with an exterior-grade sealant to deter water intrusion.

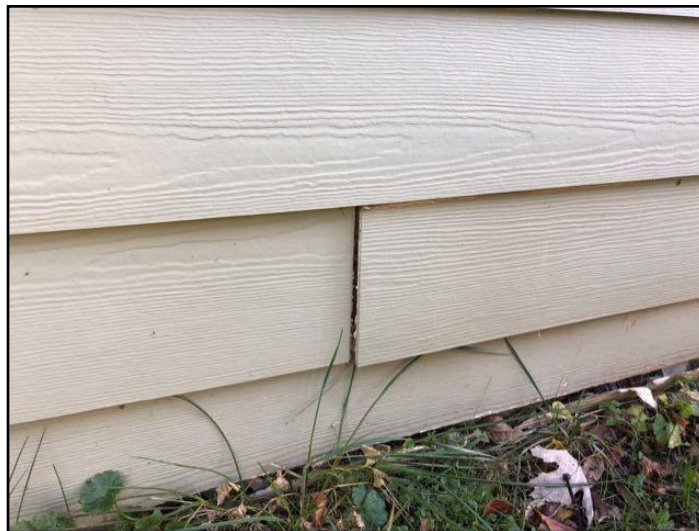
26. *Missing Caulking (or Back Flashing) at...*

16. Condition: • Missing Caulking (or Back Flashing) at Siding Butt Joint

Vertical joints in the fiber cement lap siding were neither caulked nor flashed. According to manufacturers recommendations, either practice is an allowable method of sealing the end joints of the siding. In its current state, the cladding is susceptible to moisture intrusion into the space between the siding and Water Resistant Barrier (WRB). Moisture in contact with the WRB can eventually propagate through the barrier and reach underlying, water-sensitive materials. Additionally, WRB materials tend to degrade when exposed to UV (sunlight). Flashing is typically installed during the installation process and is, therefore, not a viable means of repair. It is recommended that all vertical joints in the siding be caulked with an appropriate sealant. Caulked joints will require periodic maintenance.

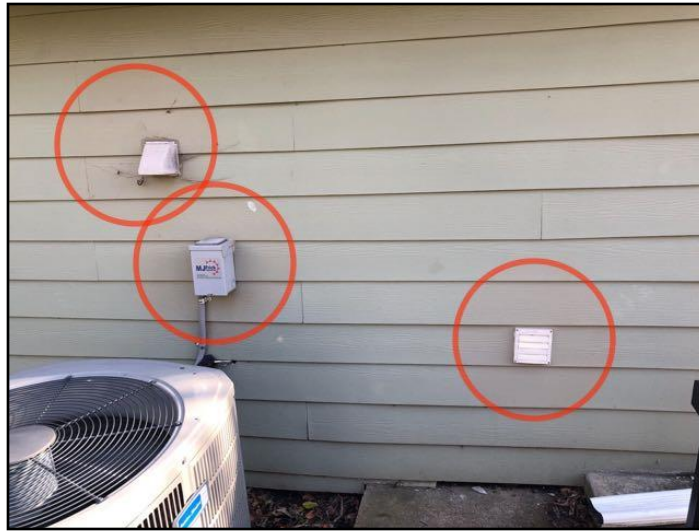
27. Missing Plinth or Mounting Block

17. Condition: • Missing Plinth or Mounting Block

Flashing details at penetrations through the fiber cement siding did not adhere to the manufacturers recommended best practices. This does not necessarily affect the performance of the materials, but does create a need for periodic maintenance. Caulking at the top of vent penetrations should be visually inspected and maintained, as needed, periodically. No current maintenance is needed.

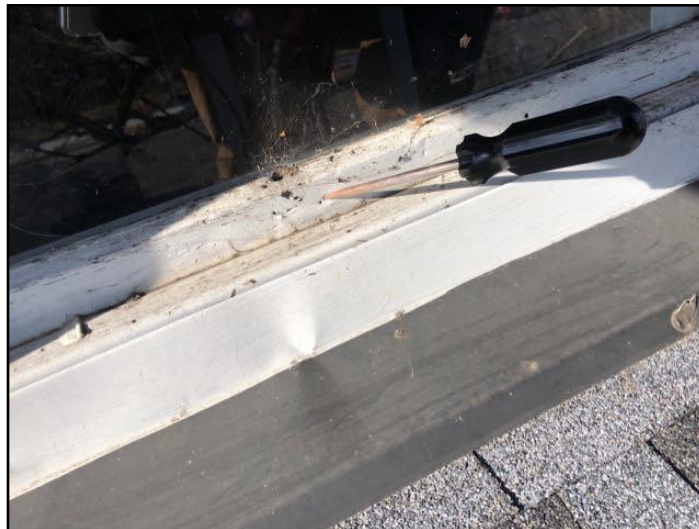
28. Soft

18. Condition: • Rot

The window sashes on the dormer were soft when probed. This is likely from moisture intrusion. It is recommended to properly flash and seal the area to prevent further deterioration.

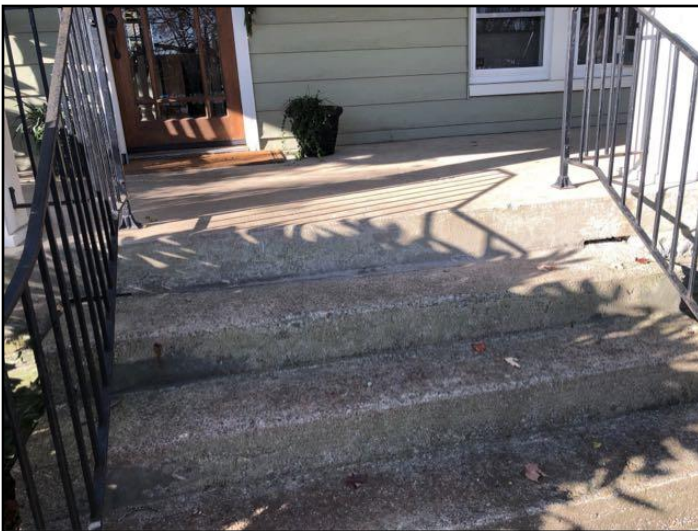
32. Steps or landings settling or heaving

22. Condition: • [Steps or landings settling or heaving](#)

Minor settlement had occurred beneath the concrete steps of the front porch. It is recommended that the resultant gap be sealed to deter moisture intrusion and further settling.

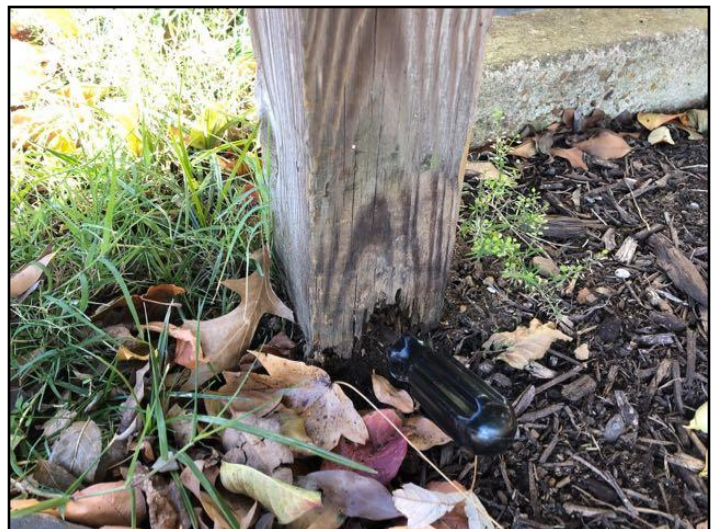
36. Loose

24. Condition: • [Loose](#)

The guardrail installed around the basement entrance was loose when tested. Upon further inspection the base of the posts were rotten. It is recommended for the posts to be repaired for the guardrail to function properly.

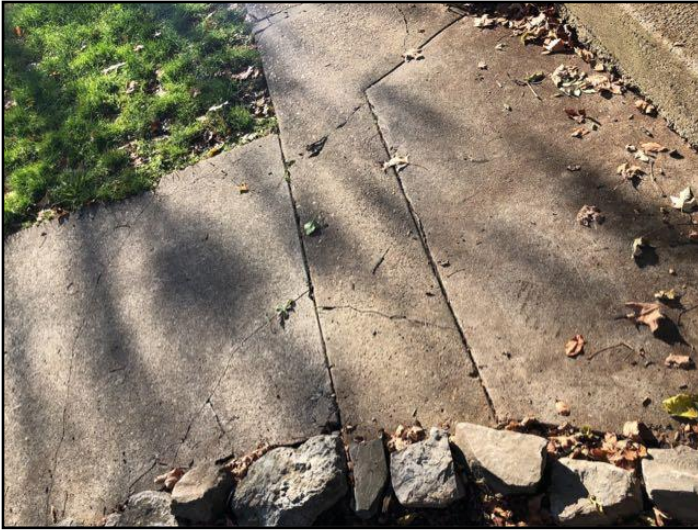
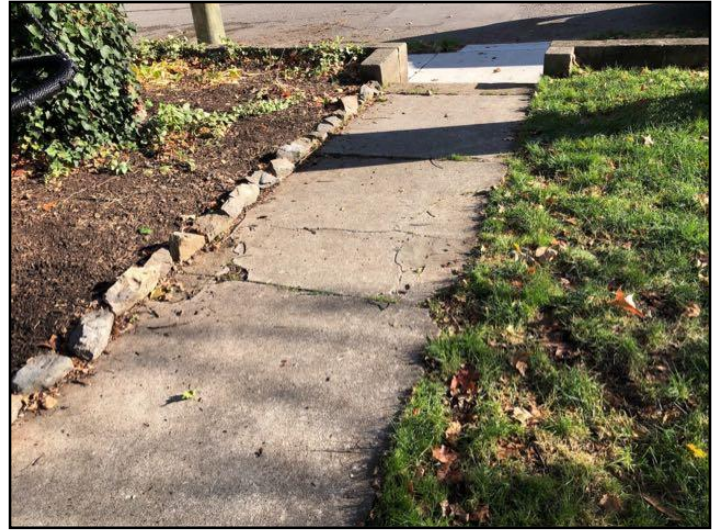
26. Condition: • [Cracked or damaged surfaces](#)

Minor cracking was observed in the walkway. This is primarily a cosmetic issue. Cracks can be filled and monitored for further movement.

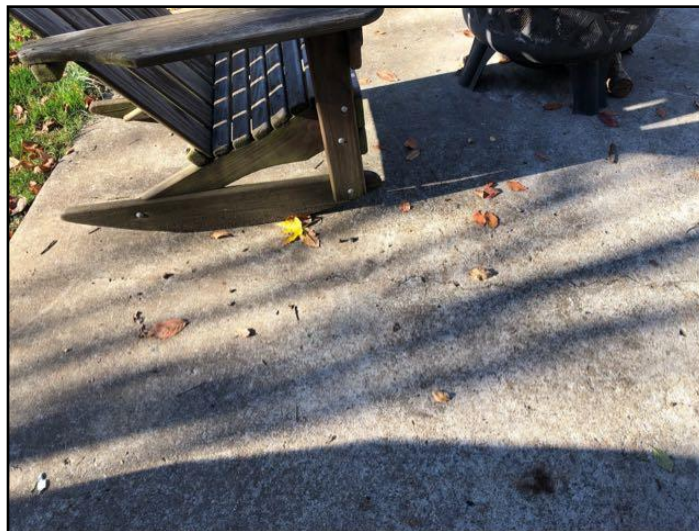
40. Cracked or damaged surfaces

27. Condition: • Cracked or damaged surfaces

Minor cracks were observed in the patio slab. Unsealed cracks should be filled and monitored for further movement.

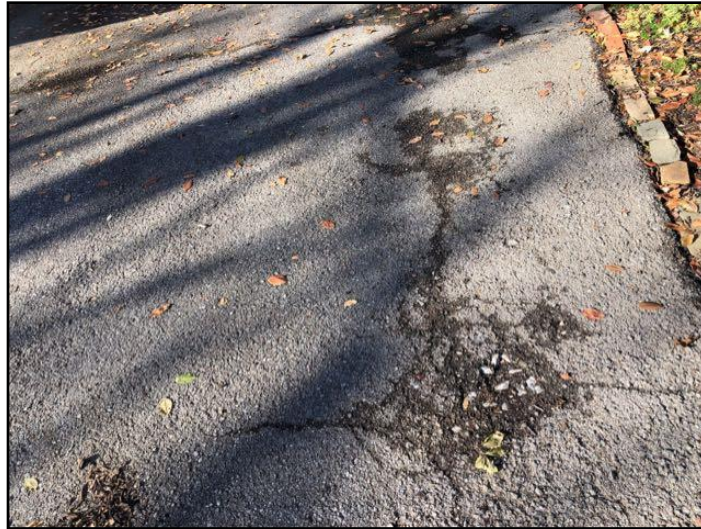
41. *Cracked or damaged surfaces*

28. Condition: • [Cracked or damaged surfaces](#)

Minor cracking was noted in the concrete driveway. Unsealed cracks should be filled with a proper crack filler and monitored for further movement.

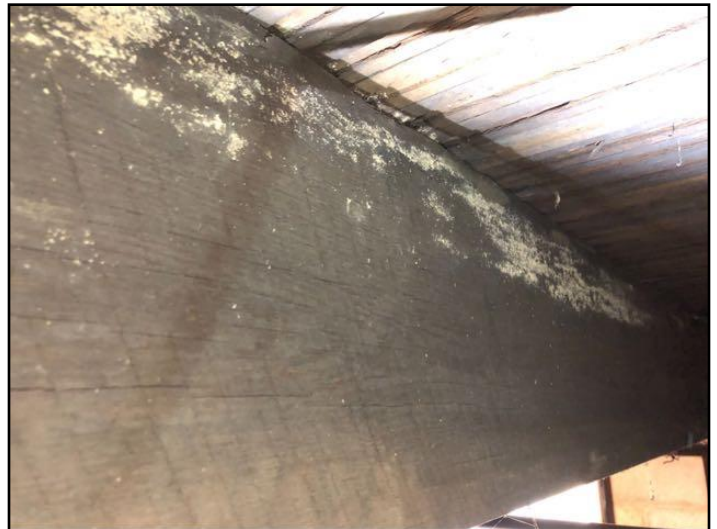
46. Minor Microbial Growth

29. Condition: • Minor Microbial Growth

Microbial growth (possible mold) was observed on the floor framing in locations throughout the crawlspace. The growth was minor in nature and consistent with growth found within vented crawlspaces in Middle Tennessee. This minor growth may be an early indicator that the vented crawlspace is not be performing as intended, but it is impossible to tell whether the growth is old or new. Mold remediation is not recommended without first addressing any potential underlying moisture. For further information or a deeper evaluation, please contact the DILIGENT office.

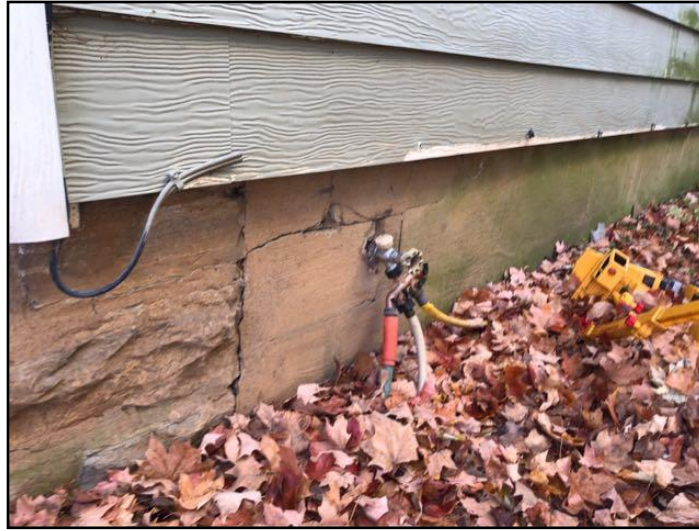
47. Cracked

30. Condition: • Cracked

Minor step cracking was present in areas of the foundation. The observed cracking was uniform with no signs of lateral movement. Cracks can be filled and monitored for signs of further movement.

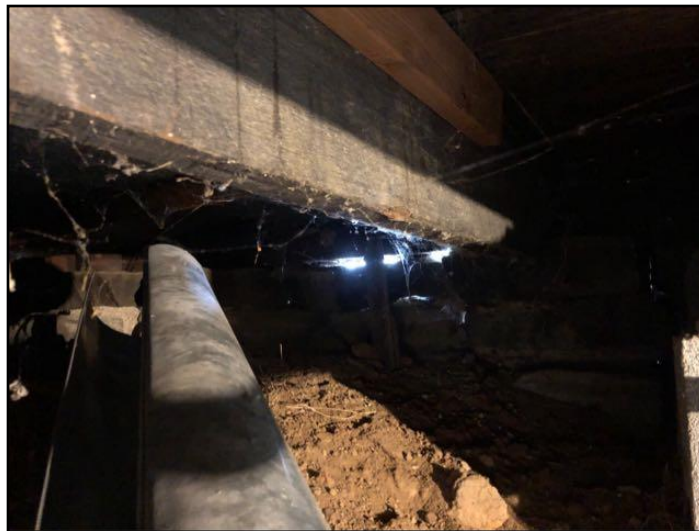
48. Holes in Foundation Wall

31. Condition: • Holes in Foundation Wall

Sizable openings through the foundation wall create an easy path for pest entry. It is recommended that all such openings be sealed with an appropriate sealant for the size of the opening (e.g. expanding foam, exterior-grade caulk, mortar).

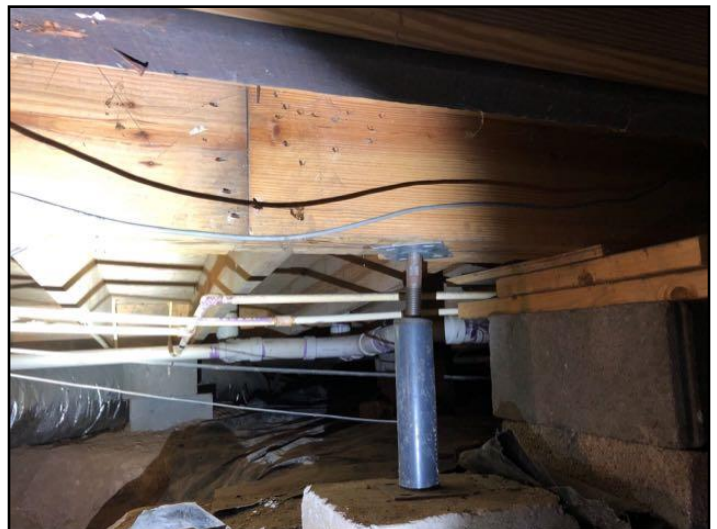
52. *Temporary jack*

32. Condition: • Several defects were noted in the flooring structure in the dug out basement and crawlspace area. Due to the accumulation of the defects noted it is recommended that the structure be evaluated by a qualified, licensed, structural engineer. The defects noted are as follows:

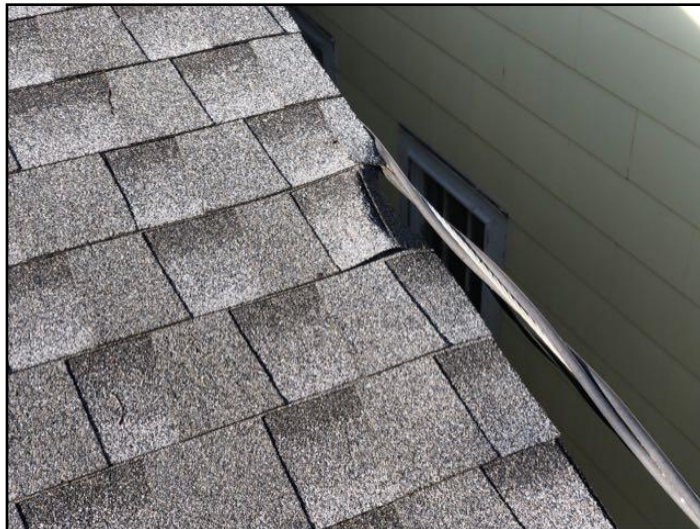
69.

34. Condition: • The service conductors are in contact with the roof surface on the right side of the roofing structure. This has caused a few of the shingles to lift. Minor adjustments are needed to prevent further damage to the shingles or the conductor insulation.

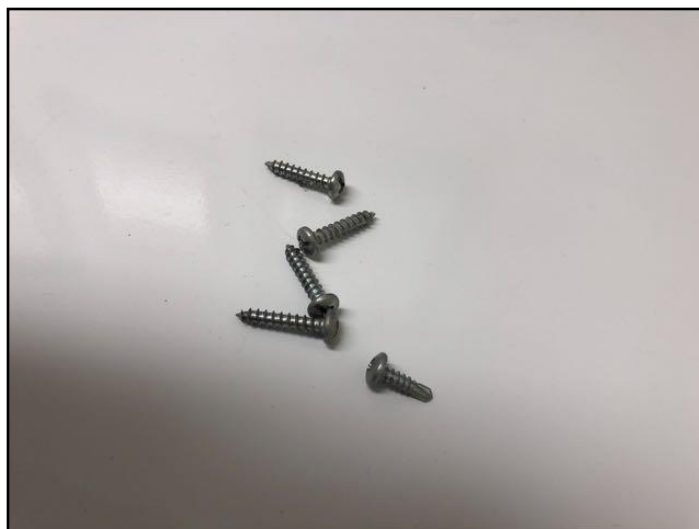
73. Improper screws

38. Condition: • Improper screws

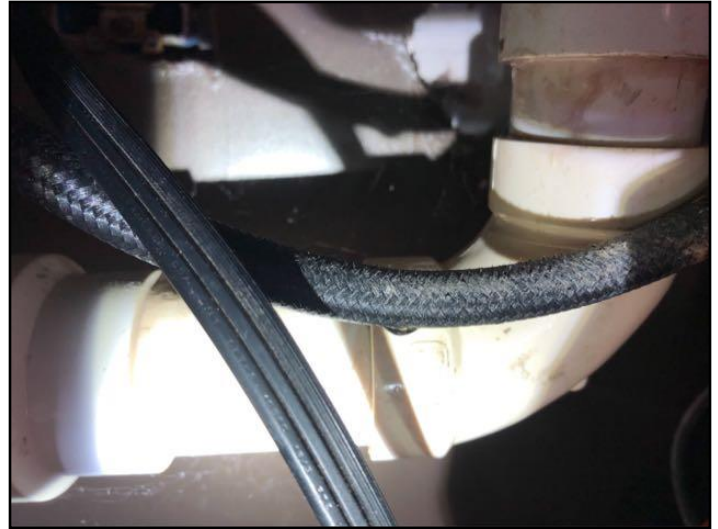
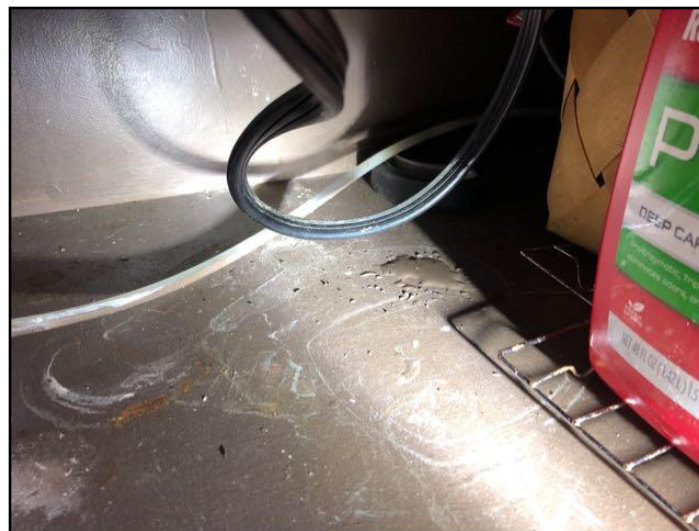
Condition: • [Drip, leak](#)

The faucet was leaking around its spout connection. The leak was dripping on the floor of the cabinet. This defect can often be repaired by replacing packing washers or O-rings within the fixture.

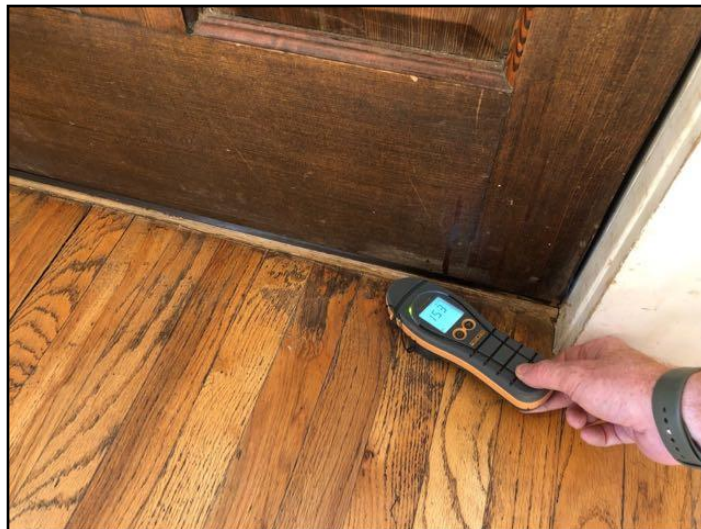
115. Water stains found dry

60. Condition: • Water stains found dry

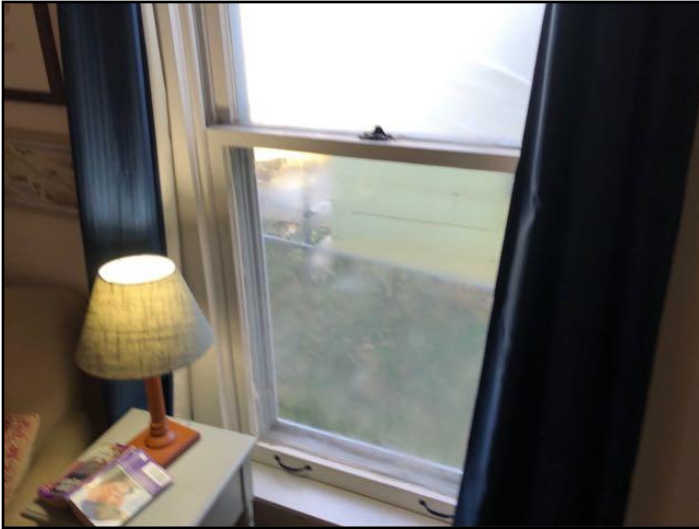
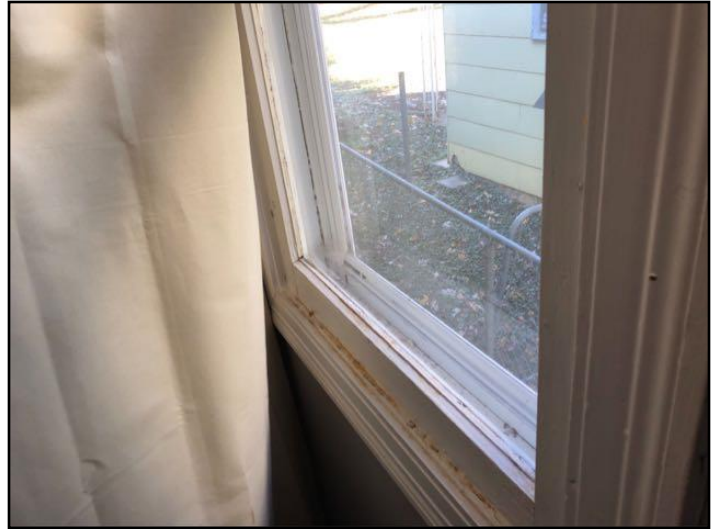
Condition: • [Inoperable](#)

Some of the windows throughout the house could not be opened with reasonable force. At least one functional window is required in all sleeping areas as a secondary means of egress. For the safety of occupants, it is recommended that necessary egress windows be repaired or replaced to fulfill this requirement. Improvement of non-egress windows is at the discretion of the homeowner.
