DILIGENT

Home Inspection Report

2217 Lindell Avenue
Nashville, TN 37204

Wednesday, December 2, 2020

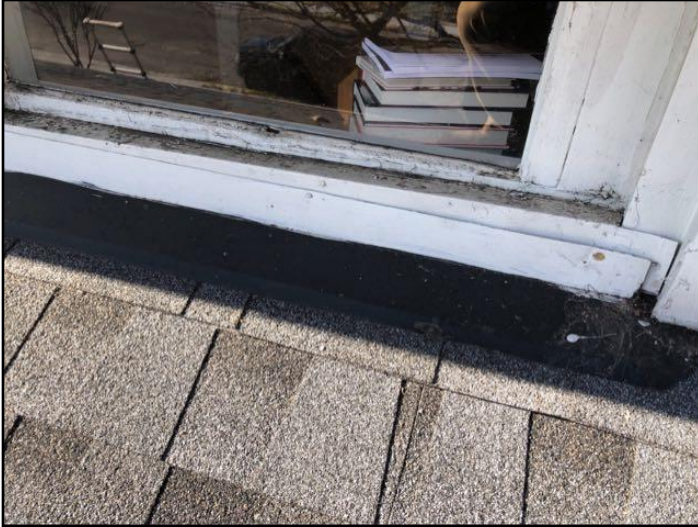
The apron flashing installed at the base of the dormer was loose, the top edge of the flashing was not sealed, and the fasteners were exposed. Repairs are needed to the flashing to prevent moisture intrusion.

2. Loose, damaged, patched, open seams

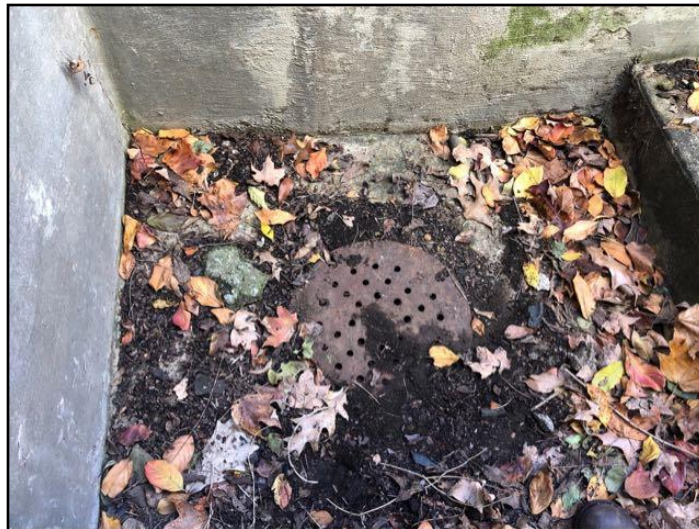
6. Underground components (e.g., oil tanks,...)

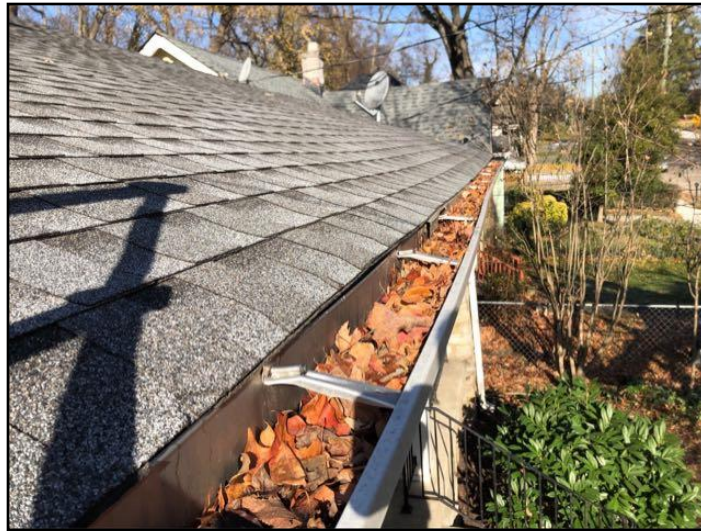
8. Dirty/debris

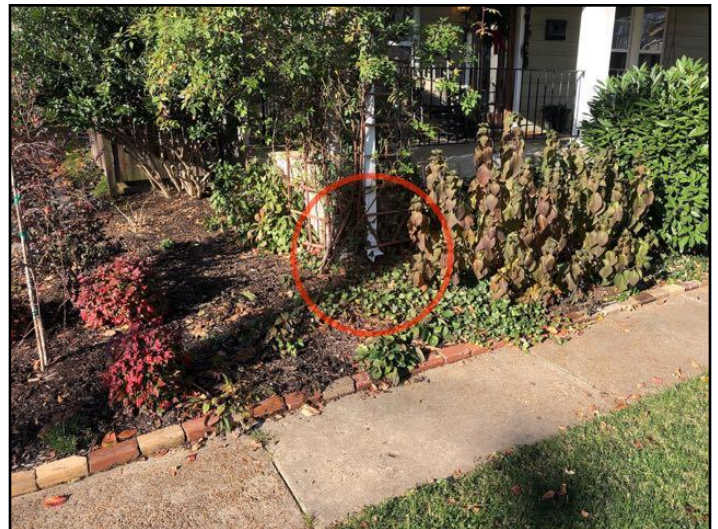
10. Discharge too close to building

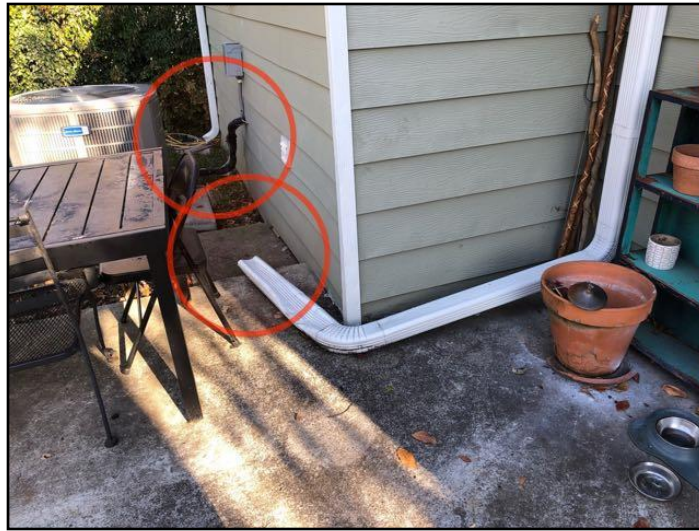
11. Discharge too close to building

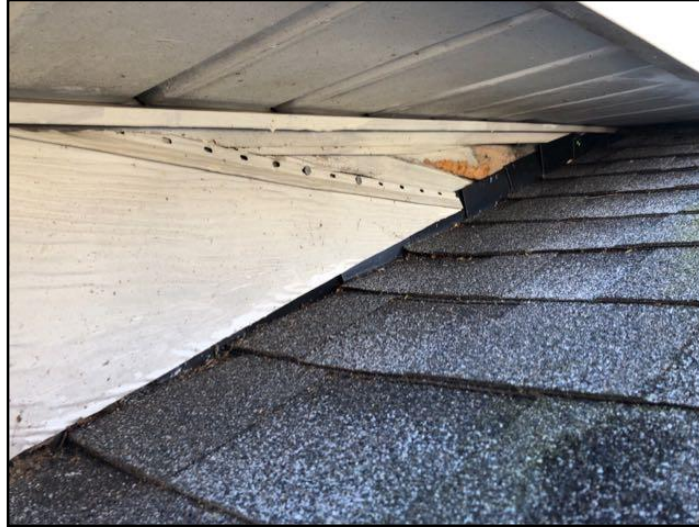
14. *Flashings incomplete or ineffective*

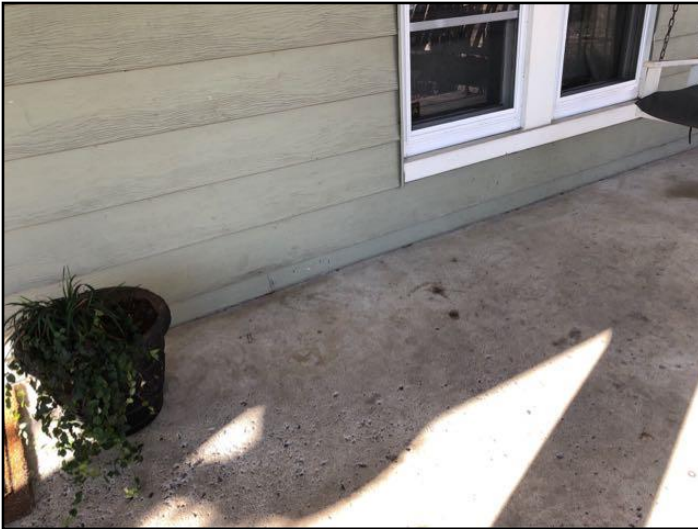
16. Too close to grade

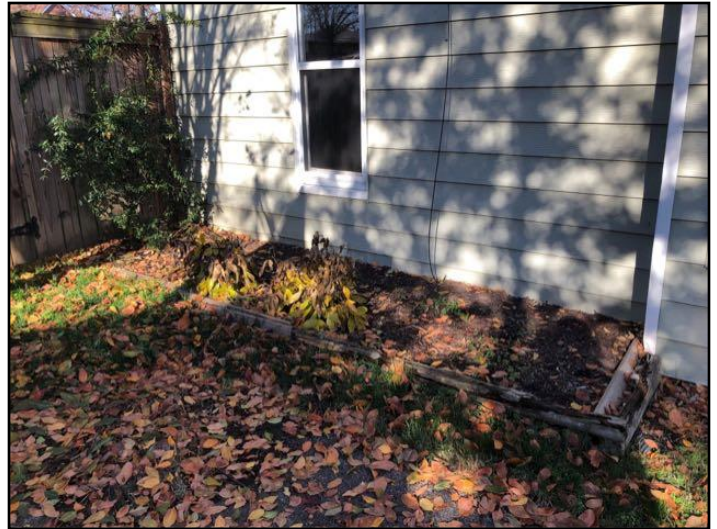
17. Too close to grade

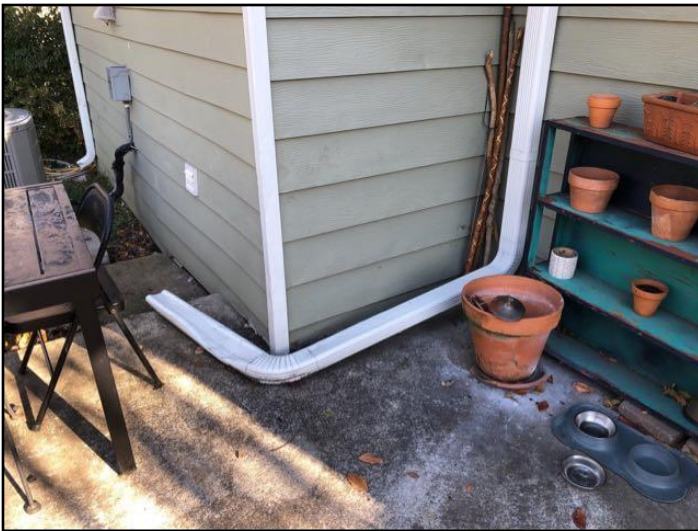
18. Too close to grade

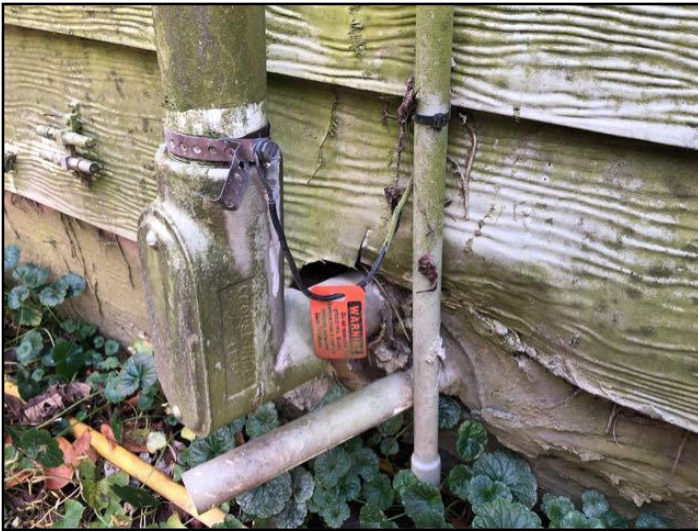
20. Openings in siding

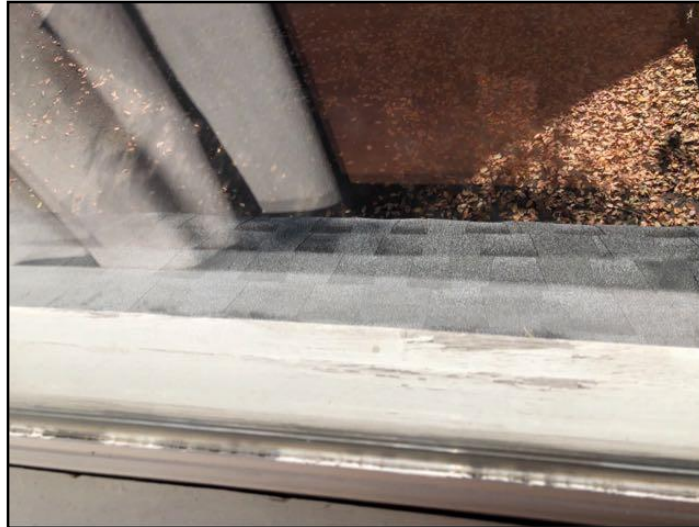
29. *Paint or stain needed*

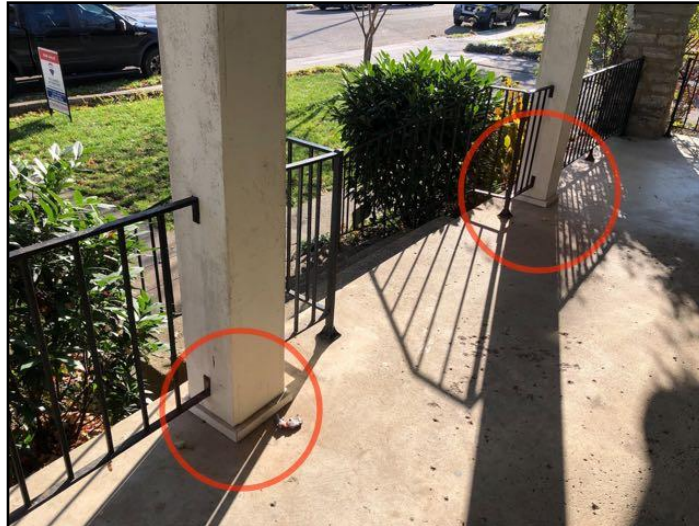
31. Column in Contact with Concrete

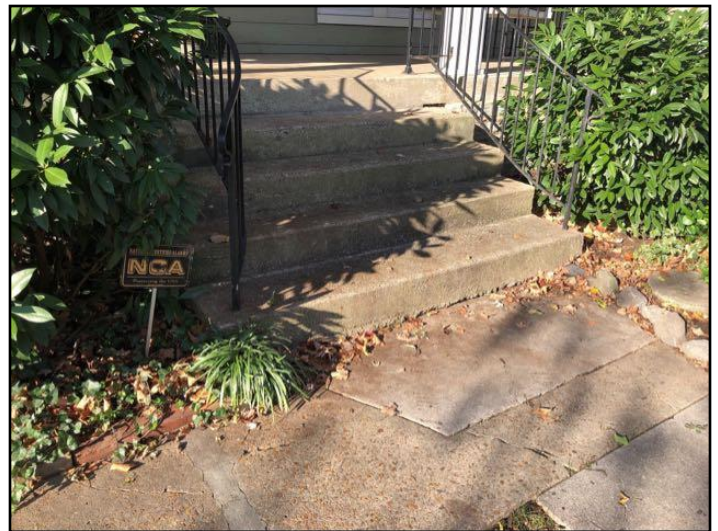
33. Steps or landings settling or heaving

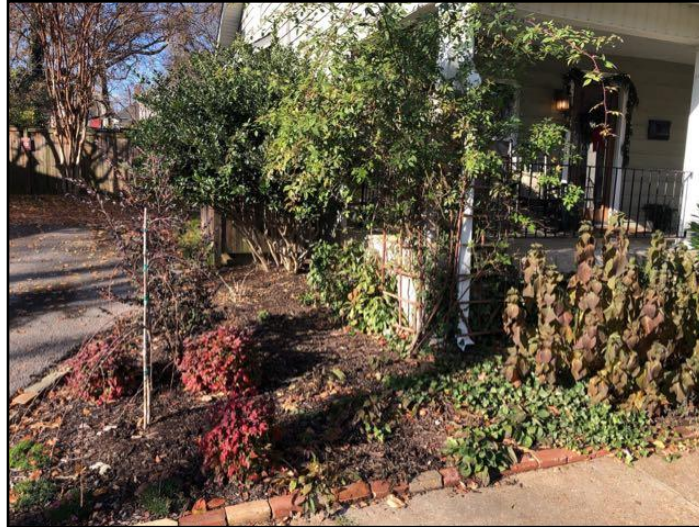
37. Trees or shrubs too close to building

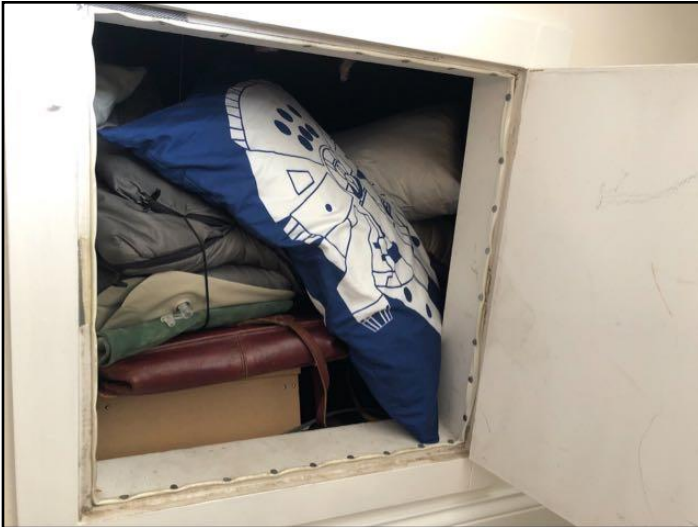
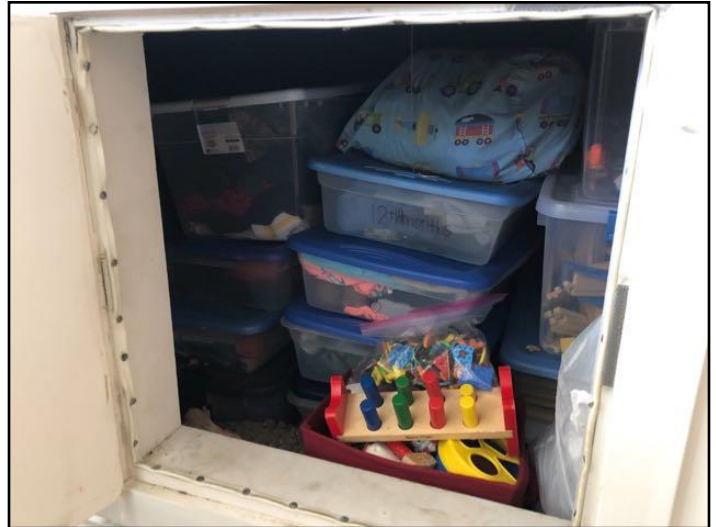
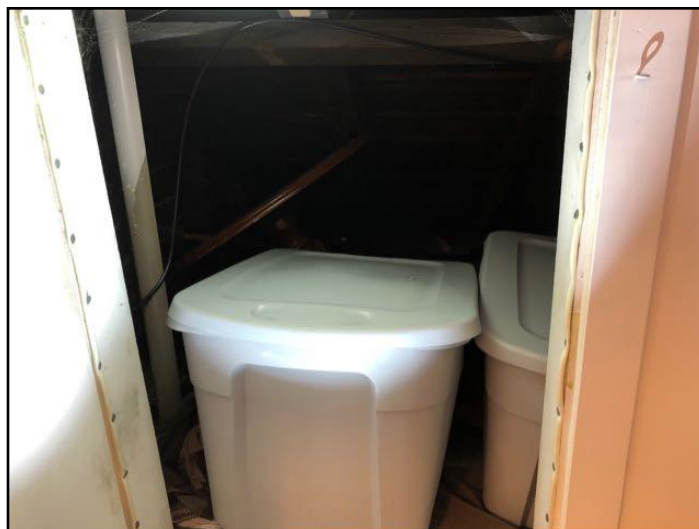
42. Storage

43. Storage

44. Storage

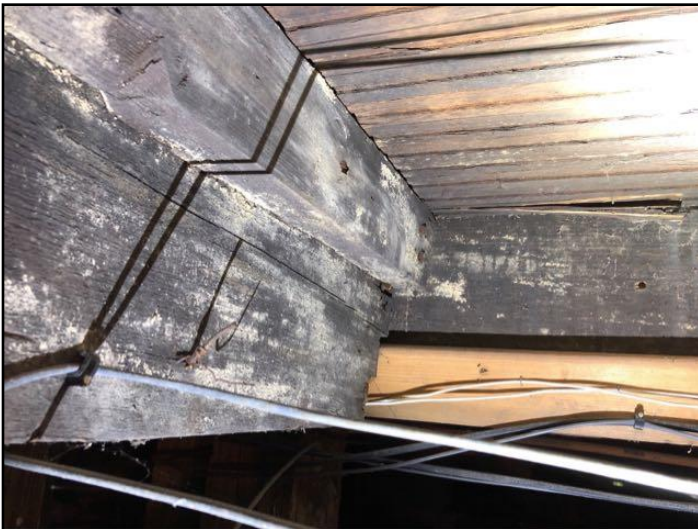
45. Minor Microbial Growth

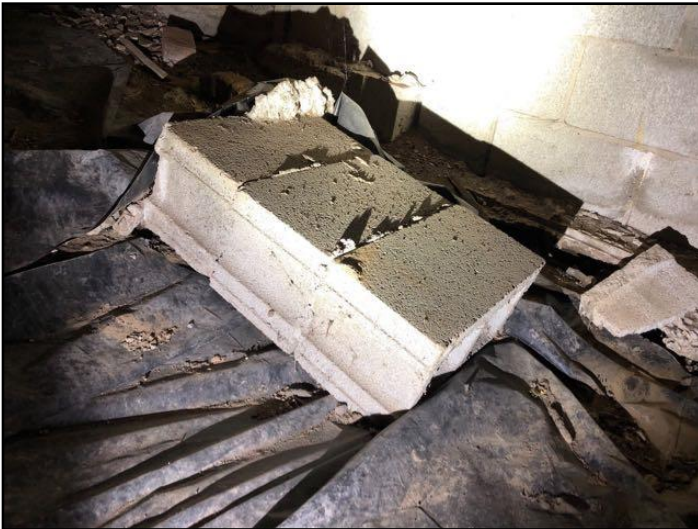
- Cracks in the foundation wall
- Deflection in the foundation wall
- Splitting of several joists where they were notched to accommodate the ledger strip
- No footings installed under several piers
- Dry stacked piers
- Leaning and racked piers
- Non-standard wooded posts and support beams
- A pier knocked over on its side
- Temporary metal jacks supporting a beam
- Joints in the built up beam not bearing directly over a pier
- Improper shim material

49. *Fallen over*

Condition: • Several defects were noted in the flooring structure in the dug out basement and crawlspace area. Due to the accumulation of the defects noted it is recommended that the structure be evaluated by a qualified, licensed, structural engineer. The defects noted are as follows:

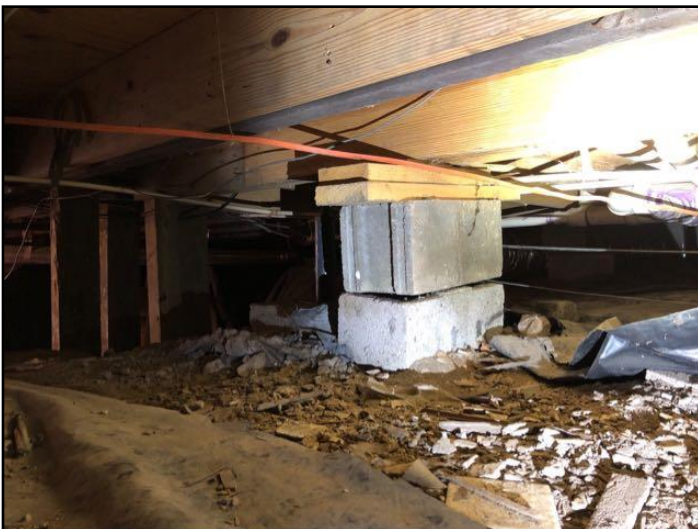
51. *Improper shim and installation*

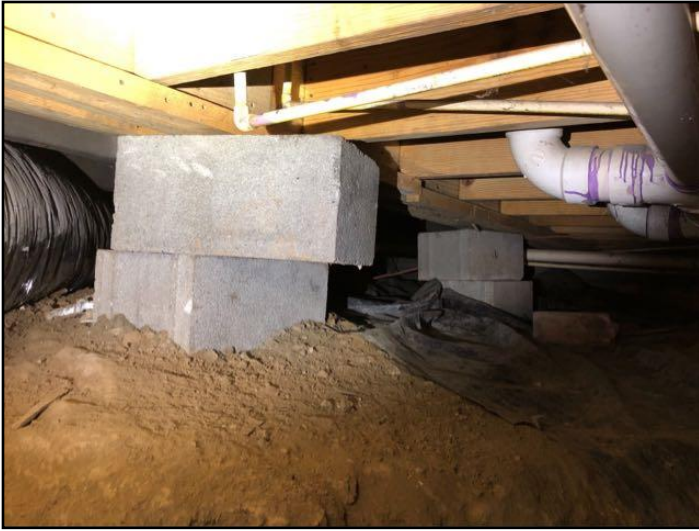
53. Dry stacked and racked

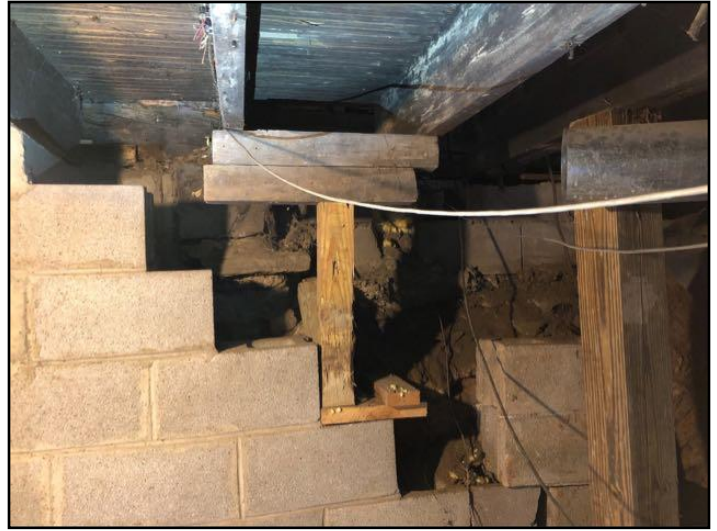
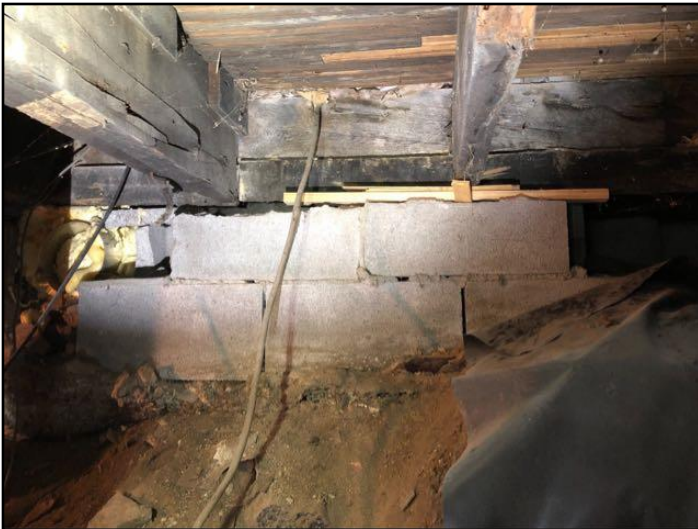
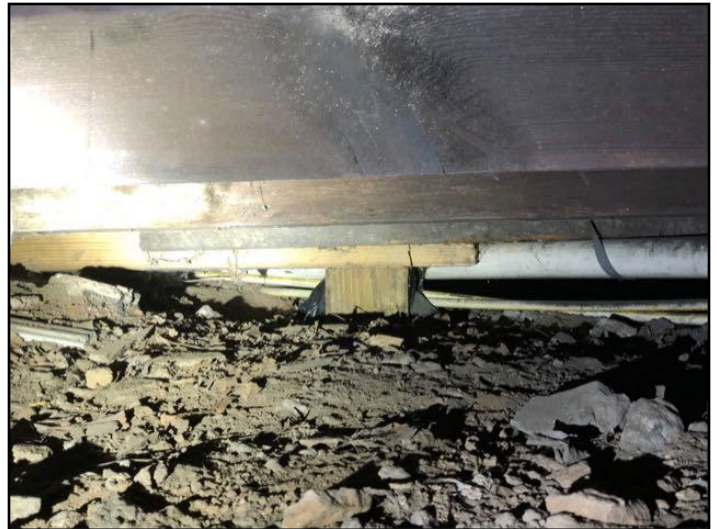
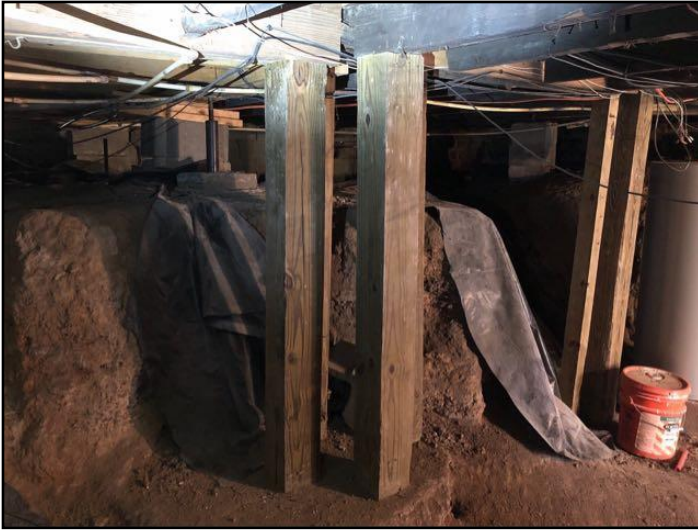
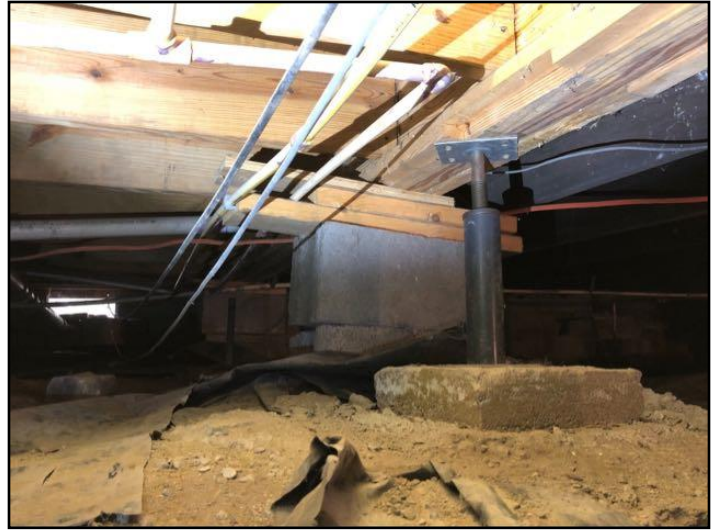
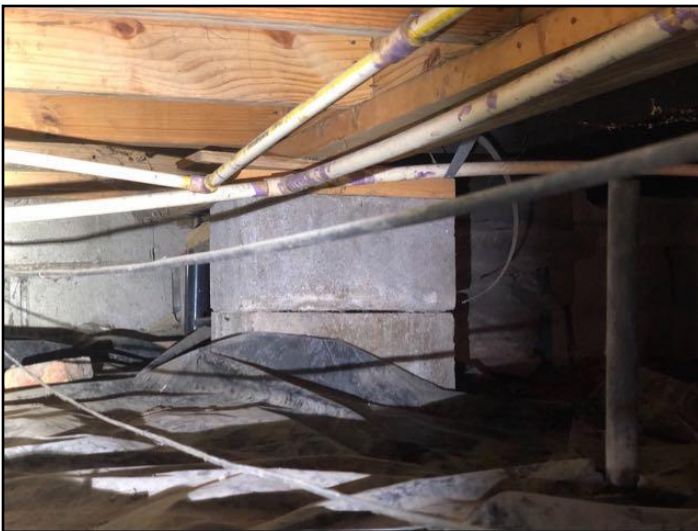
58. Prior repairs

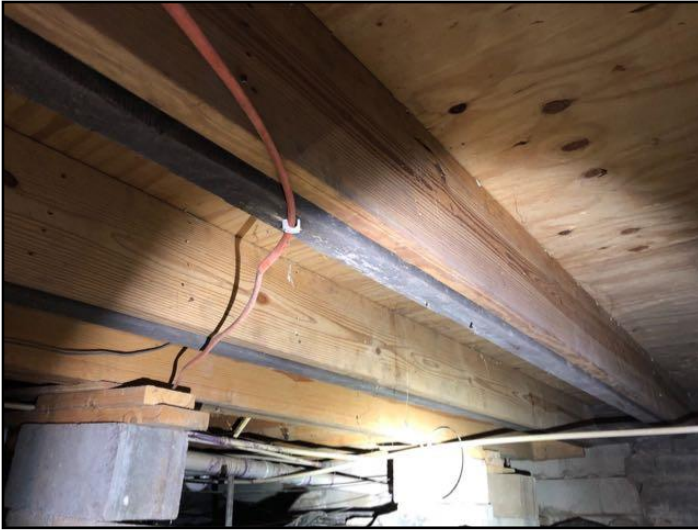
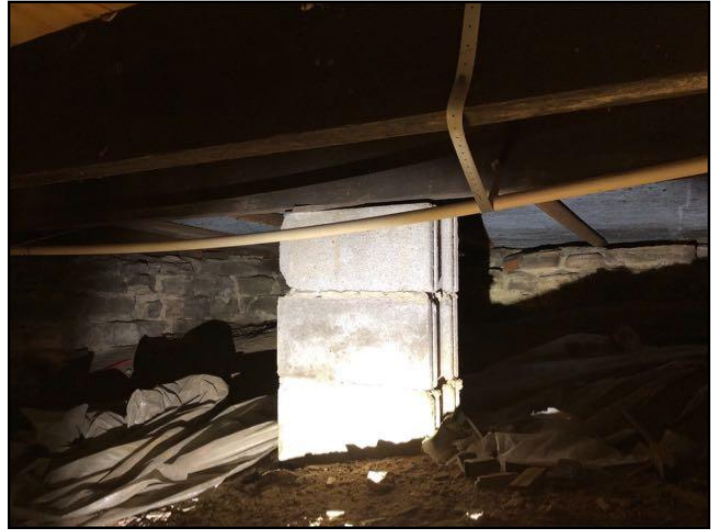
65. Prior repairs

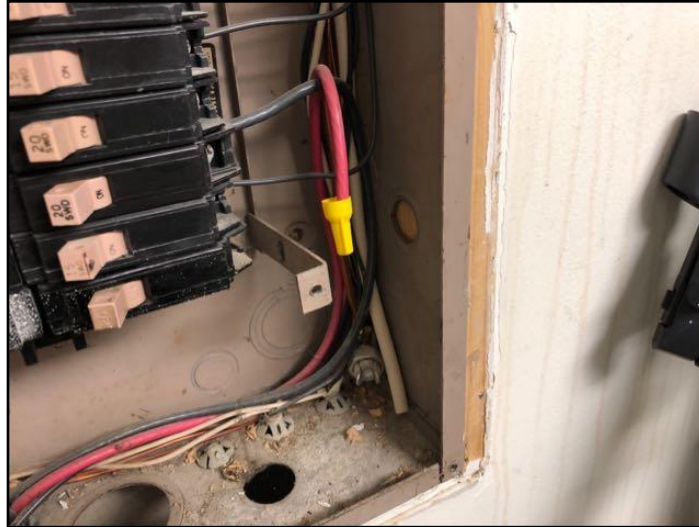
74. Abandoned wires in panel

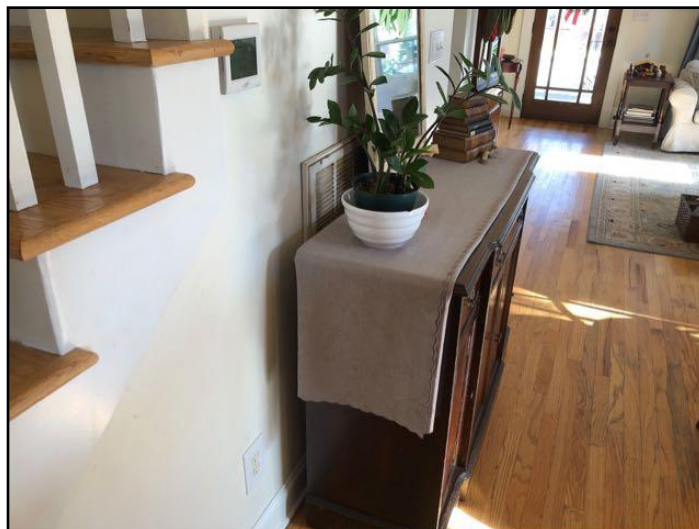
81.

Inspection limited/prevented by: • Low outdoor temperature

Inspection limited/prevented by: • Lack of access to return plenum

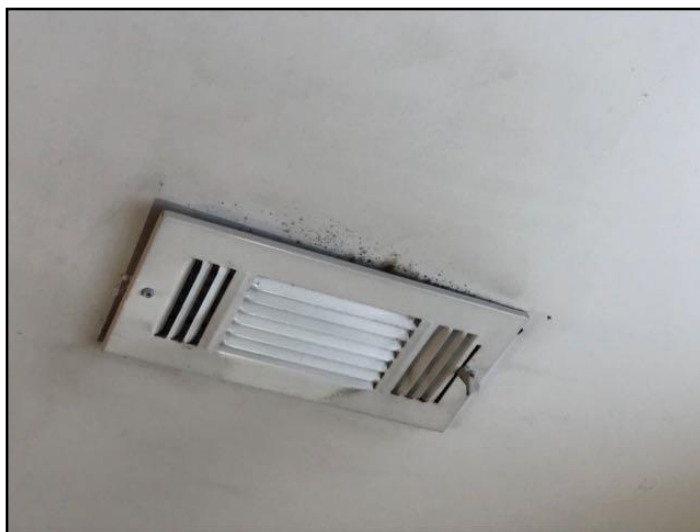
45. Condition: • [Incomplete](#)

Microbial growth was noted around a register in the ceiling of the back right bedroom. Microbial growth can form from elevated humidity levels or from moisture presence. Maintenance was needed on duct insulation at boot connections. Uninsulated duct can generate a significant amount of condensation. Insulation should be pulled back into place, if possible, and secured with foil tape or mastic. Otherwise, new insulation can be installed in affected areas. The area measured dry at the time of inspection and is believed to be an intermittent issue. It is recommended to clean the area and to monitor for growth.

83. *Incomplete*

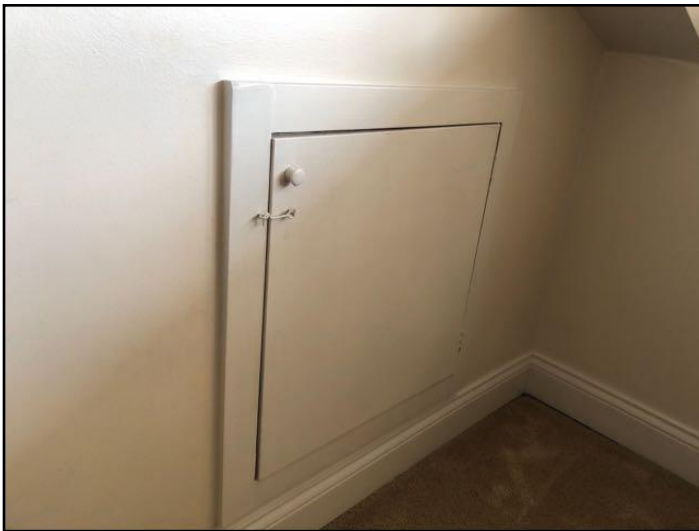
46. Condition: • [Not insulated](#)

84. Not insulated

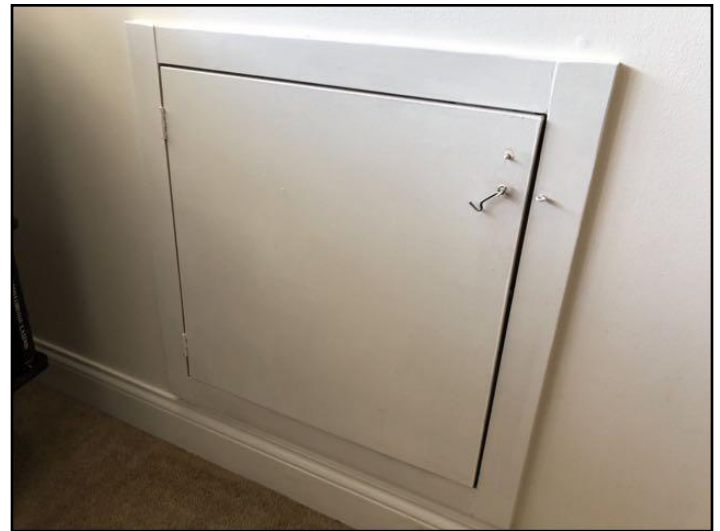
85. Not insulated

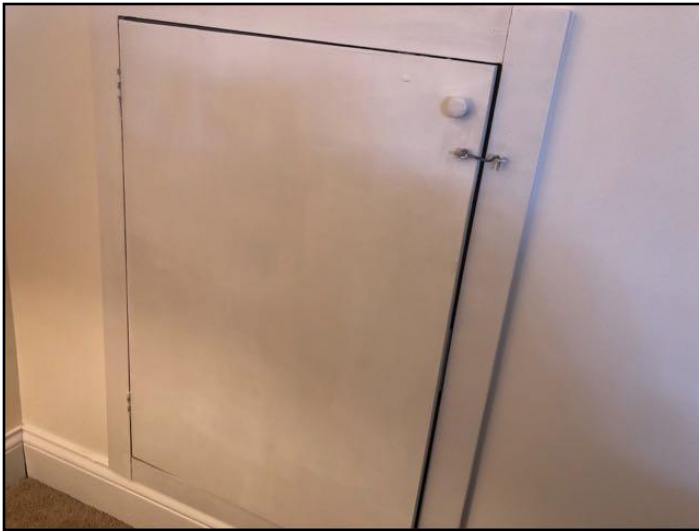
86. Not insulated

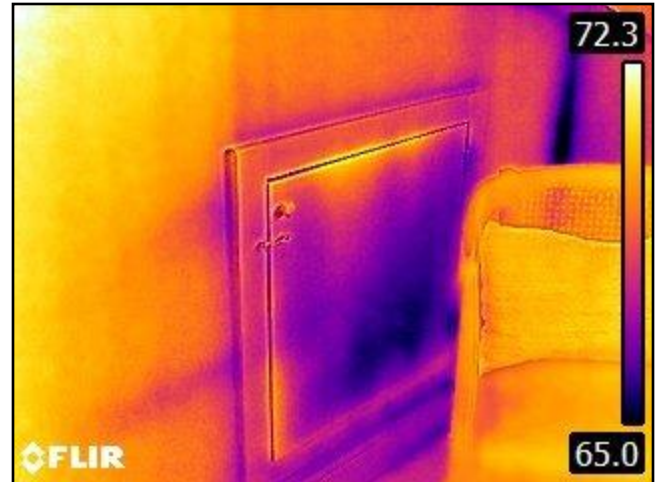
87. Not insulated

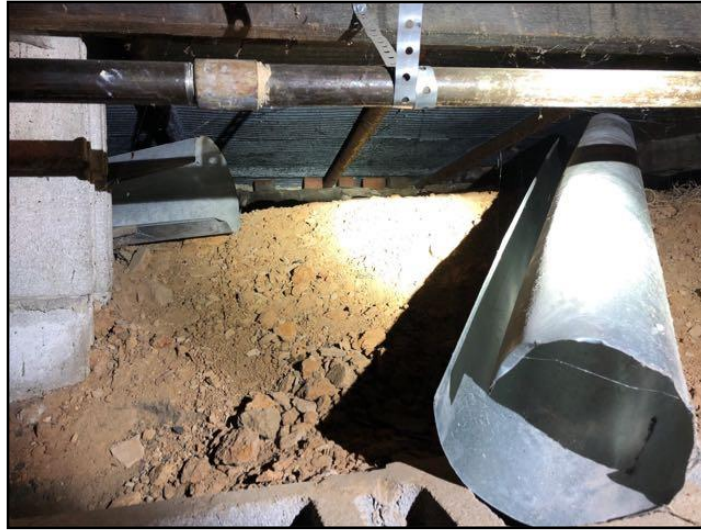
47. Condition: • Incomplete vapor barrier

Some areas of the crawlspace were without a sealed, continuous vapor barrier. Without a proper vapor barrier, ground moisture can rise and condense on wood members, HVAC components, plumbing etc. and create conditions conducive to decay, mold growth or Wood Destroying Organisms (WDO).

89. Incomplete vapor barrier

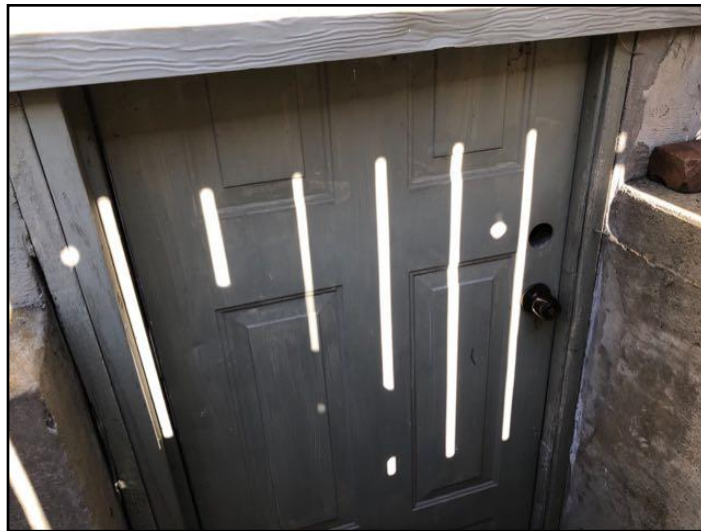
90.

48. Condition: • The basement/crawlspace door was poorly secured in its opening. The upper hinge was loose causing the door to bind on its frame. Minor adjustments are needed for the door to open and close properly.

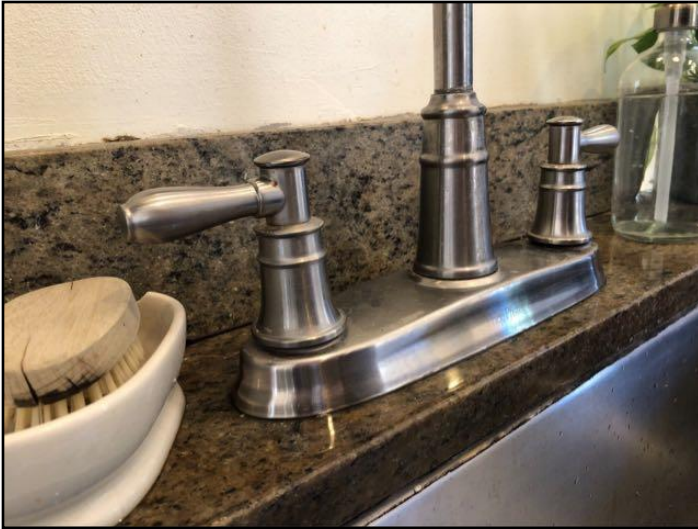
50. Condition: • [Drip, leak](#)

The faucet was leaking around its spout connection. The leak was dripping on the floor of the cabinet. This defect can often be repaired by replacing packing washers or O-rings within the fixture.

96. Drip, leak

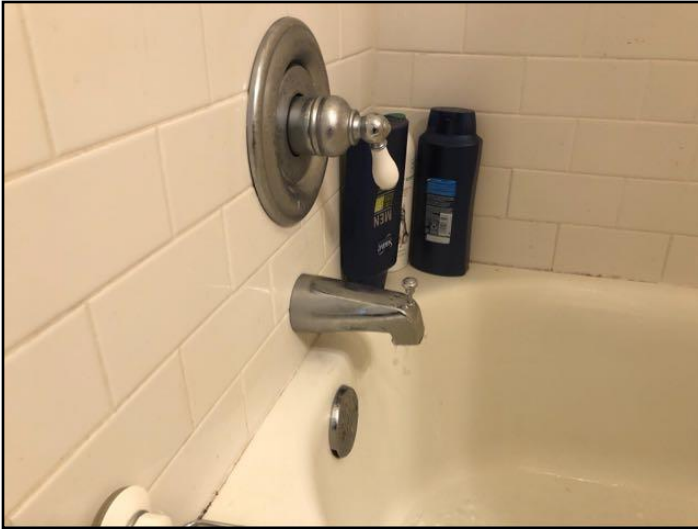
51. Condition: • [Loose](#)

The faucet was notably loose to the wall. Repetitive movement of the faucet can increase the potential for leakage at supply fittings beneath the fixtures.

99. Loose

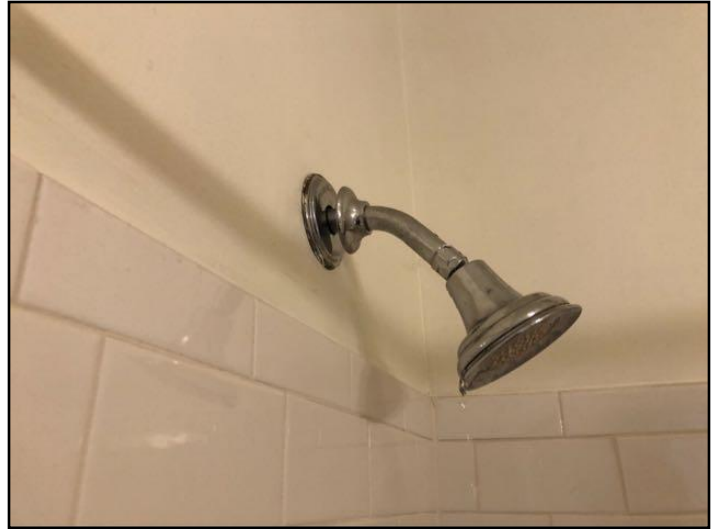
100. Loose

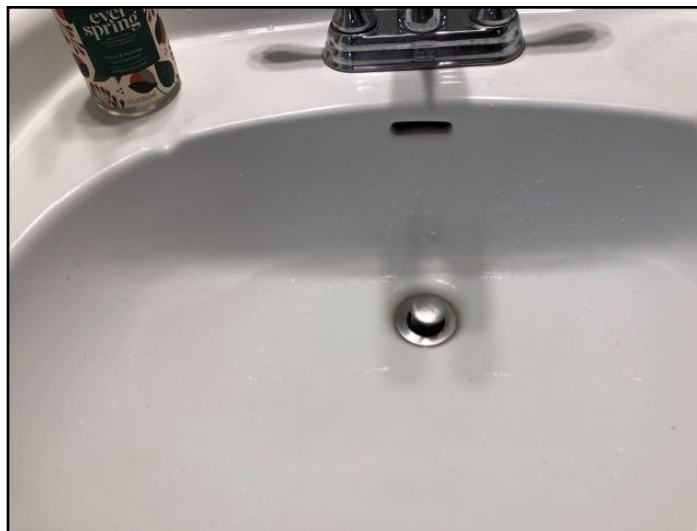
52. Condition: • Drain stop ineffective

101. Drain stop ineffective

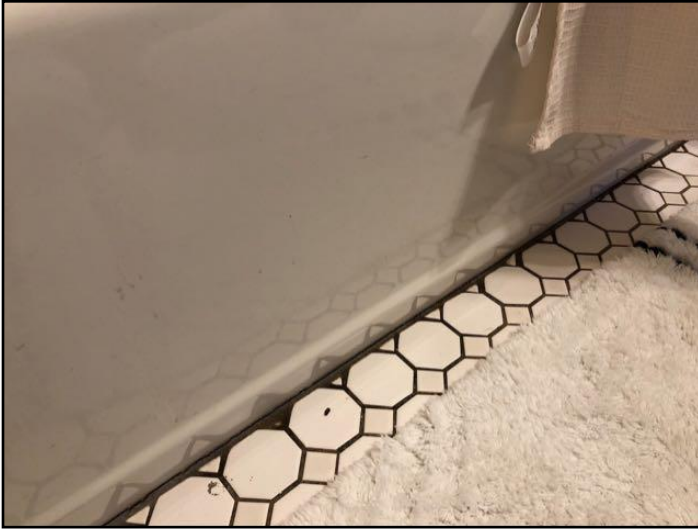
53. Condition: • [Caulking loose, missing or deteriorated](#)

102. *Caulking loose, missing or deteriorated*

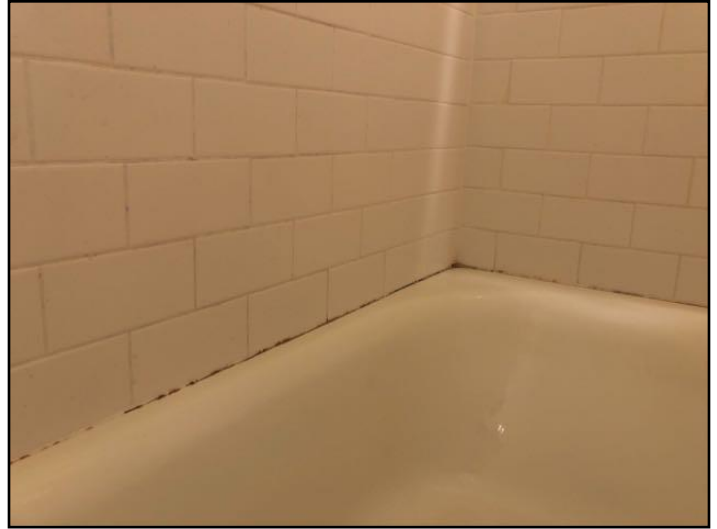
103. *Caulking loose, missing or deteriorated*

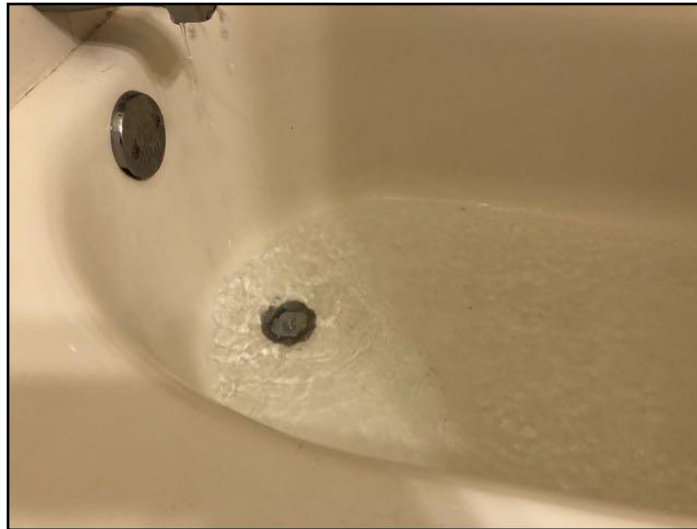
54. Condition: • [Slow drain](#)

104. *Slow drain*

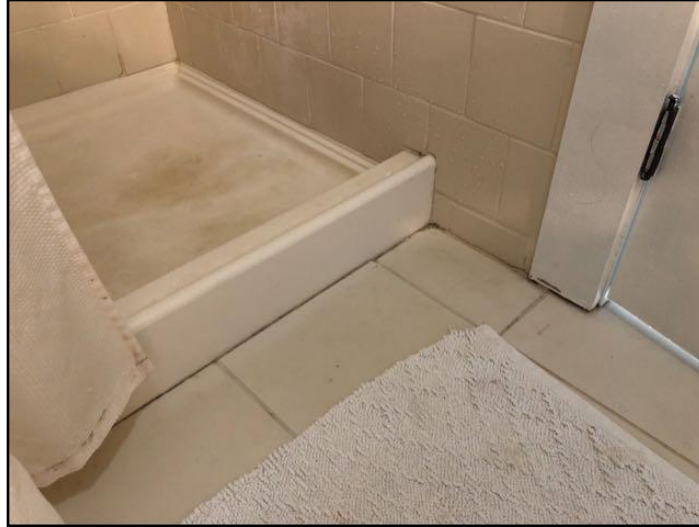
55. Condition: • [Caulking loose, missing or deteriorated](#)

Caulking at the base of the walk-in shower was in need of maintenance in some areas. Water intrusion at these locations can cause decay or mold growth in framing and subfloors, as well as, damage the bond of the tile.

105. *Caulking loose, missing or deteriorated*

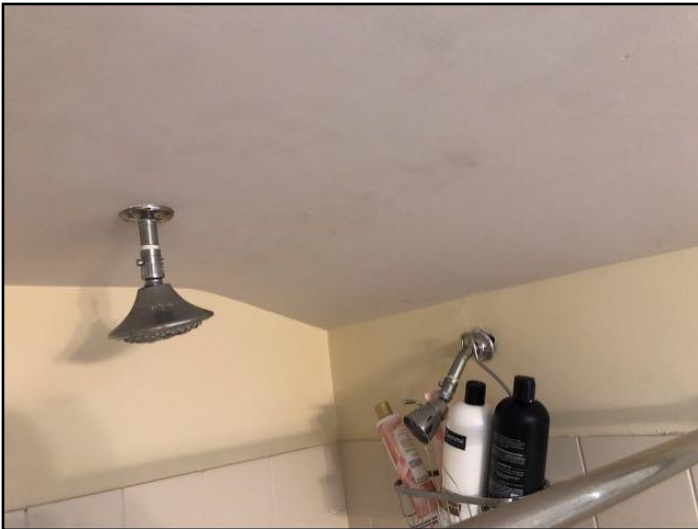
56. Condition: • [Grout loose, missing or deteriorated](#)

Cracks and missing grout were noted in the grout joints of the indicated shower. These cracks should be filled with an appropriate sealant to prevent moisture intrusion to surrounding materials. Additionally, the shower heads were leaking from their connection to the wall and ceiling and a significant amount of deposits were noted on the tile walls.

106. *Grout loose, missing or deteriorated*

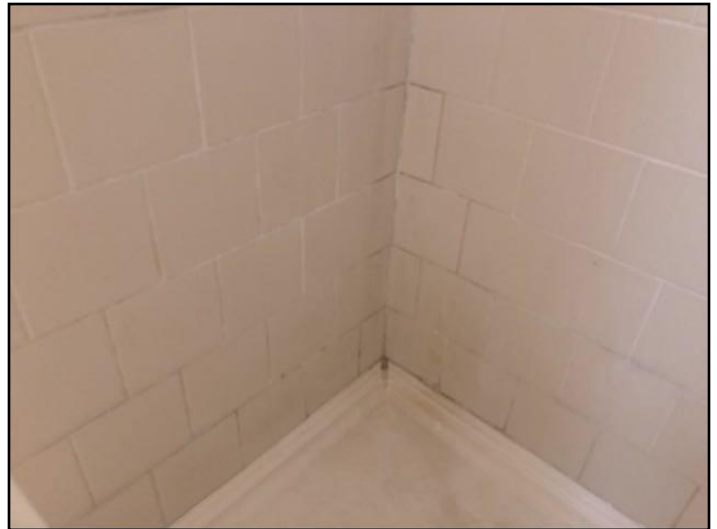
107. *Grout loose, missing or deteriorated*

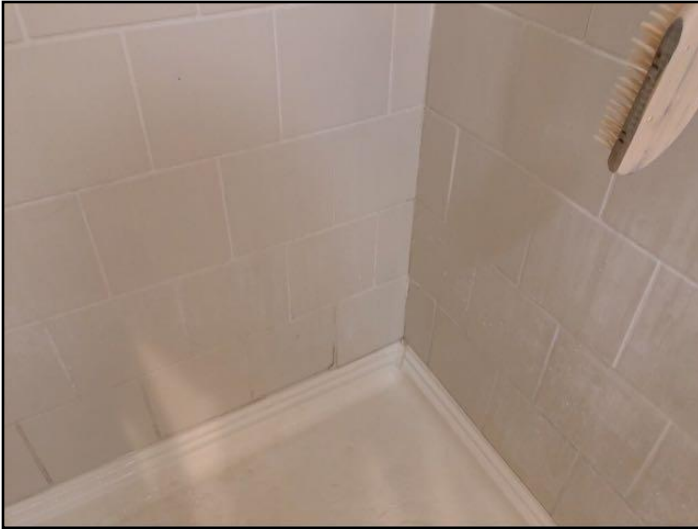
108. Grout loose, missing or deteriorated

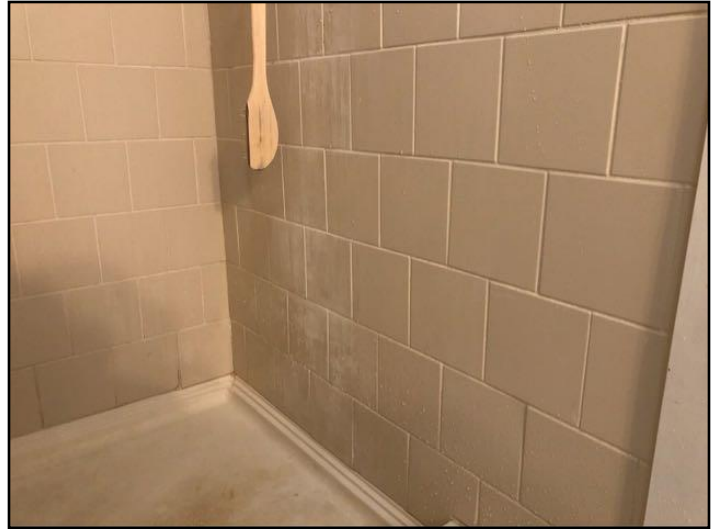
109. Grout loose, missing or deteriorated

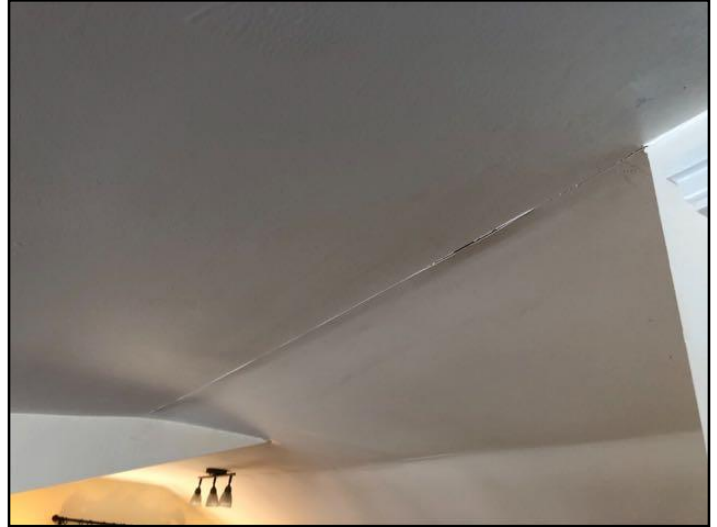
57. Condition: • [Cracked](#)

Cracks were noted in the plaster ceiling in the second floor of the home. This is primarily a cosmetic issue likely from expansion and contraction of building components.

113. Cracked

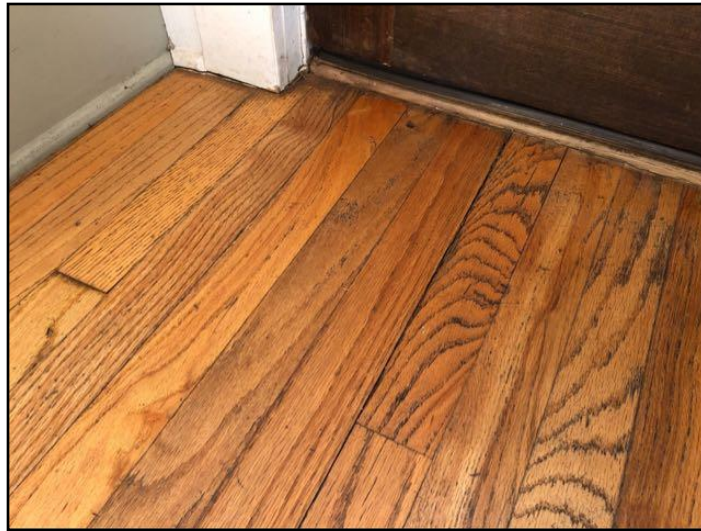
59. Condition: • Wide seams between floorboards

Wide seams were noted between floorboards of the hardwood floors. This cosmetic defect is often caused by poor installation or shrinkage of materials after installation. Improvement to aesthetics may be possible during refinishing of the floors.

114. Wide seams between floorboards

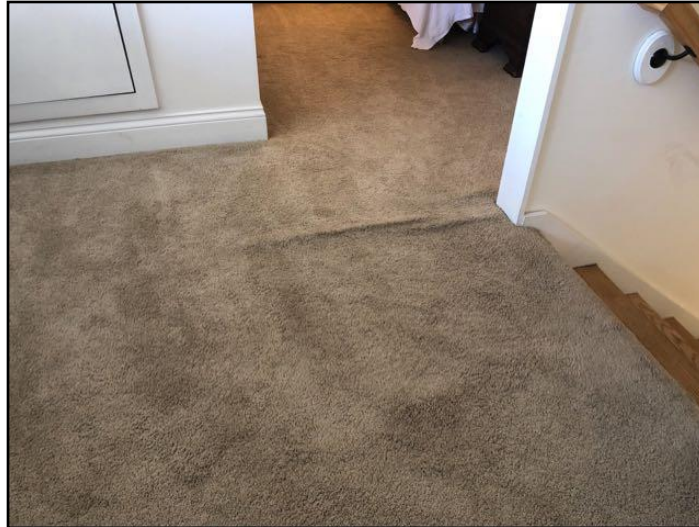
61. Condition: • [Buckled](#)

The carpet was wrinkled in areas of the home, creating minor trip hazards. The carpet can likely be re-stretched to correct this issue.

116. *Buckled*

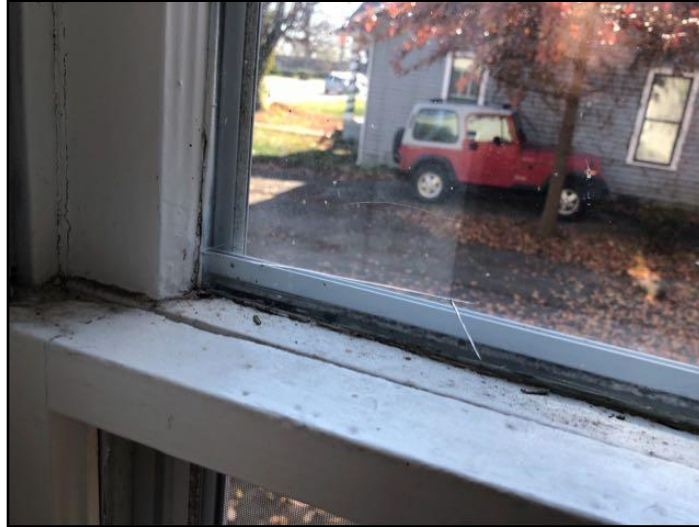
63. Condition: • [Cracked](#)

Broken/cracked glass was noted on the indicated window on the left side of the home. Repair/replacement is recommended.

118. Cracked

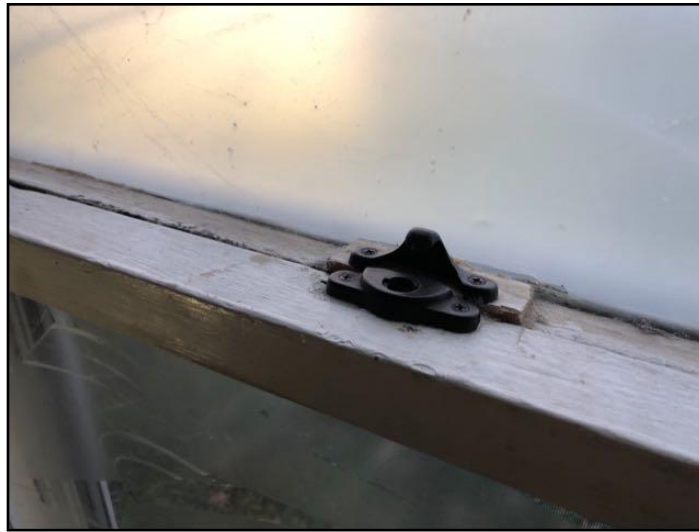
122. Broken

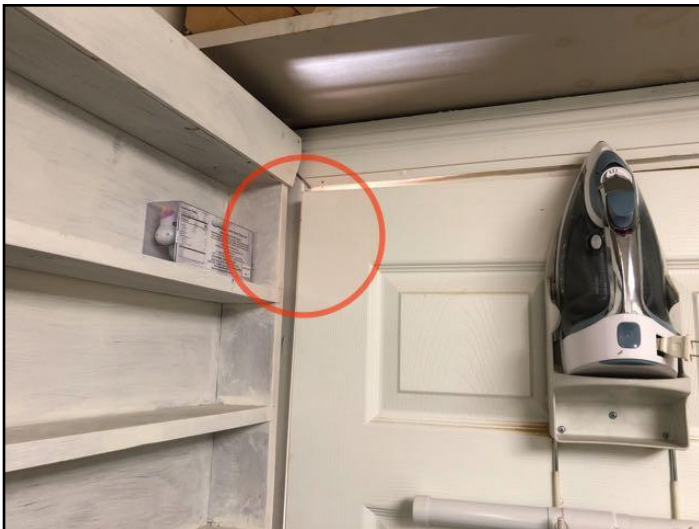
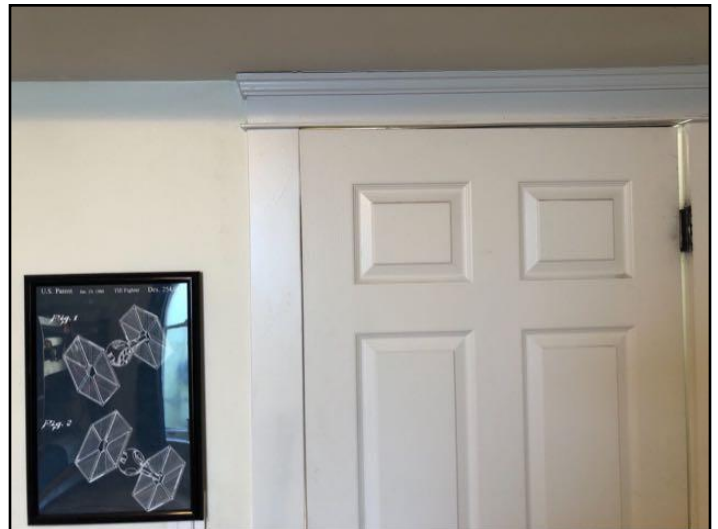
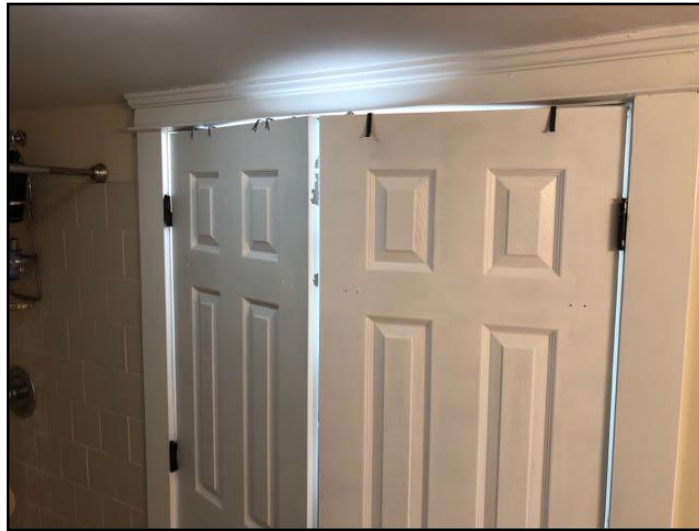
67. Condition: • Binds

123. Binds

124. Binds

125. Binds
