DILIGENT

Home Inspection Report

2217 Lindell Avenue
Nashville, TN 37204

Wednesday, December 2, 2020

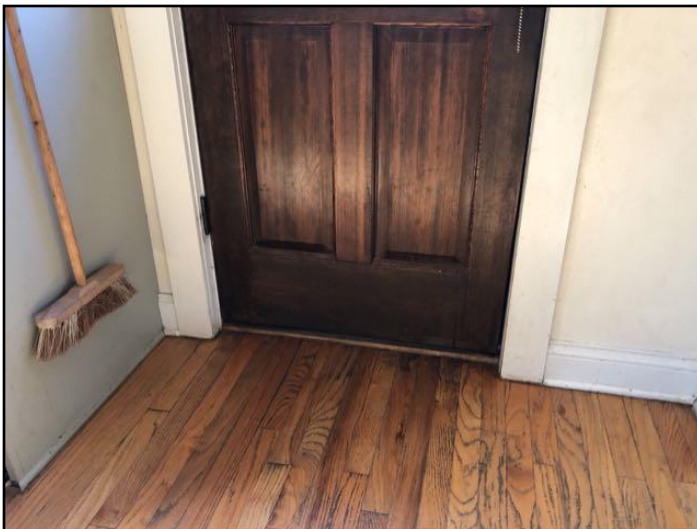
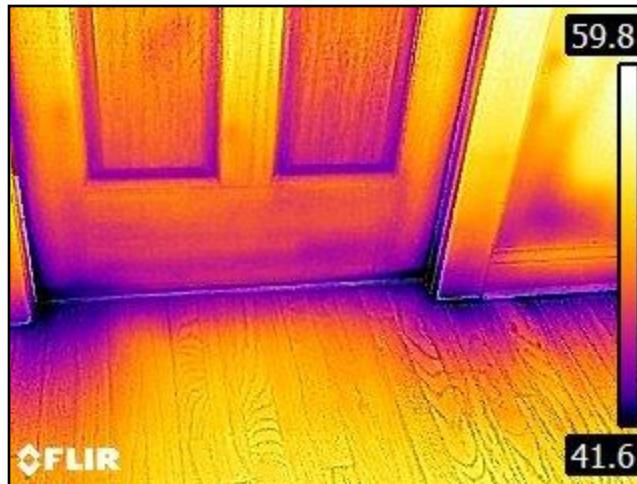
68. Condition: • [Weatherstripping missing or ineffective](#)

The weather stripping and skirt of the exterior doors was ineffective. Weather stripping around doors provides a seal that helps to prevent communication of air between the interior and exterior of the building, affecting energy efficiency and indoor air quality. It is recommended that the exterior doors are properly weather stripped.

126. Weatherstripping missing or ineffective

127. Weatherstripping missing or ineffective

128. Weatherstripping missing or ineffective

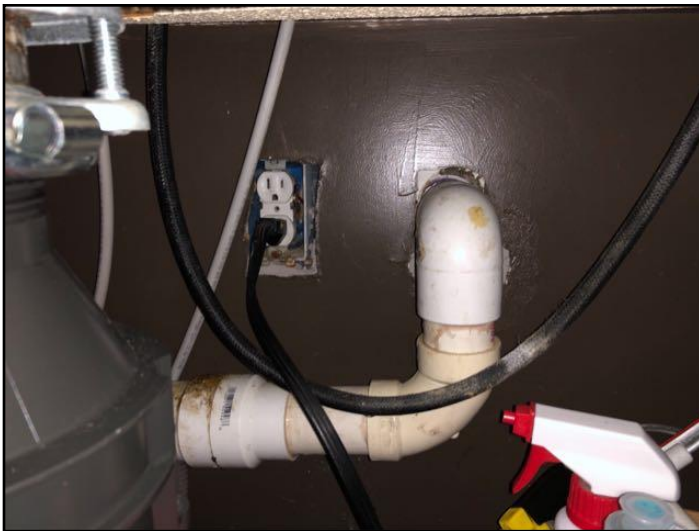
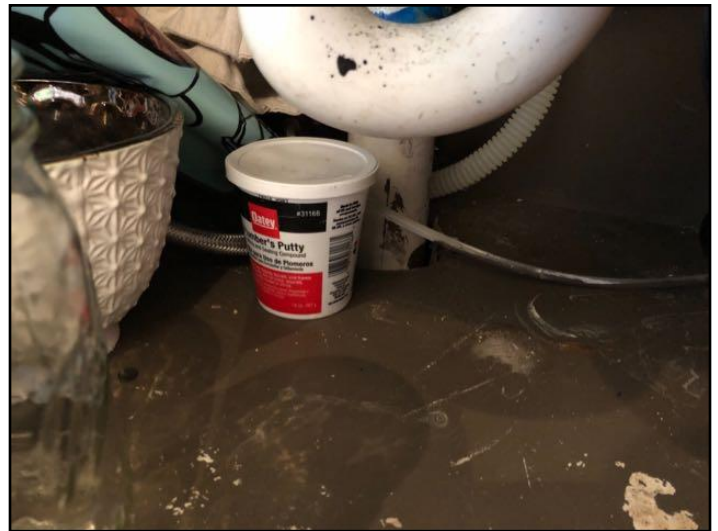
69. Condition: • Unsealed openings for plumbing penetrations

129. Unsealed openings for plumbing penetrations

130. Unsealed openings for plumbing penetrations

It is recommended that openings for plumbing penetrations be sealed to prevent communication of air between conditioned and unconditioned spaces.

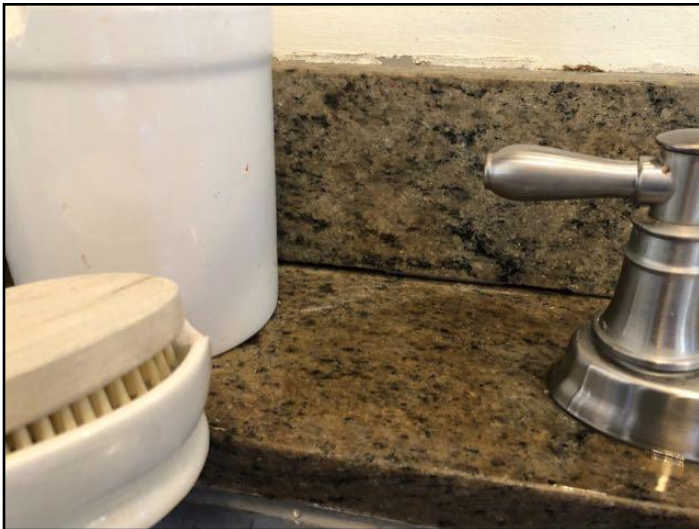
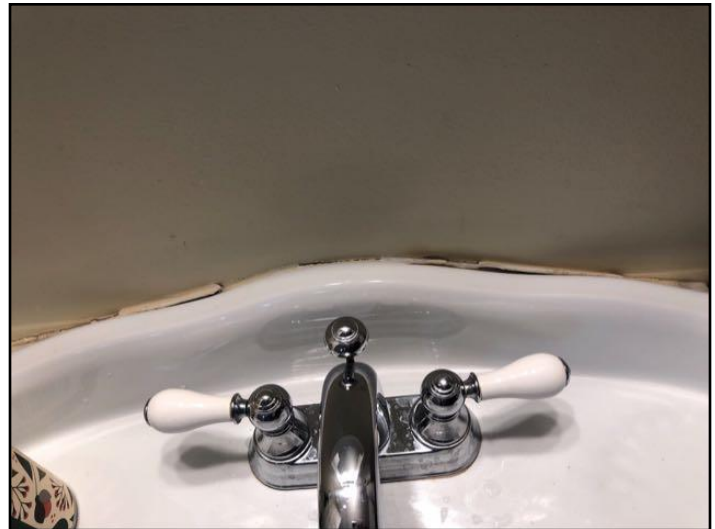
70. Condition: • Countertop needs sealant

131. Countertop needs sealant

132. Countertop needs sealant

It is recommended that the joint between the countertop and wall be sealed to prevent stray moisture from entering this area and potentially causing damage to materials.

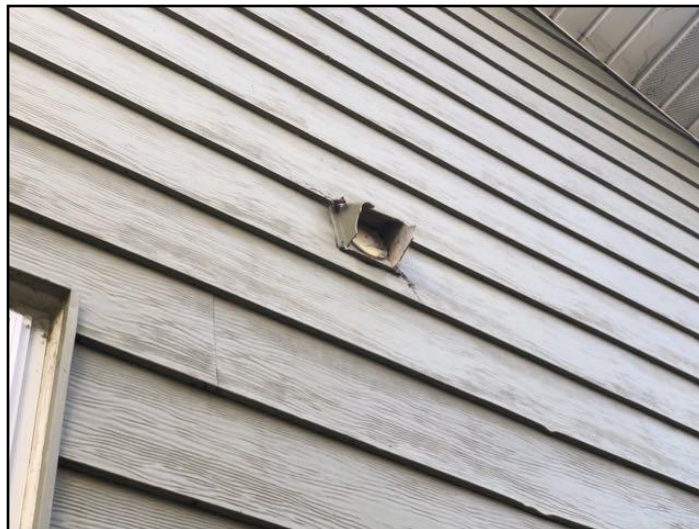
71. Condition: • [Damage](#)

The bathroom vent fan termination cover is damaged. Repair or replacement of the cover is recommended.

133. Damage
